PRIMARY RECORD

*Resource Name or # (Assigned by recorder) 550 Betz Road, Rio Oso

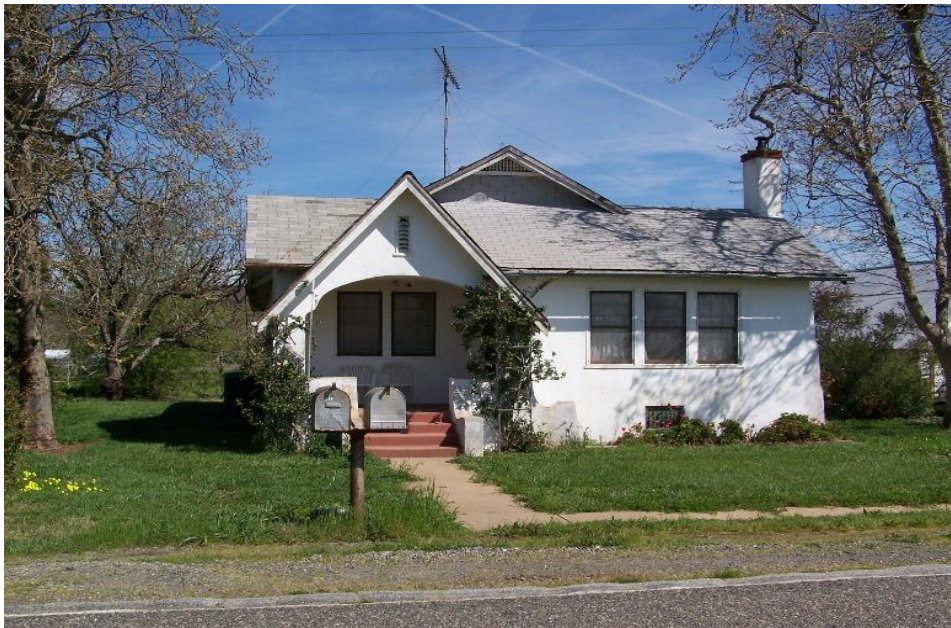
P5b. Description of Photo: (view, date, accession #) View looking north at the façade, April 18, 2006

Alterations to the building include what appears to be a circa 1920s roof at the front porch. The condition of the building is good.

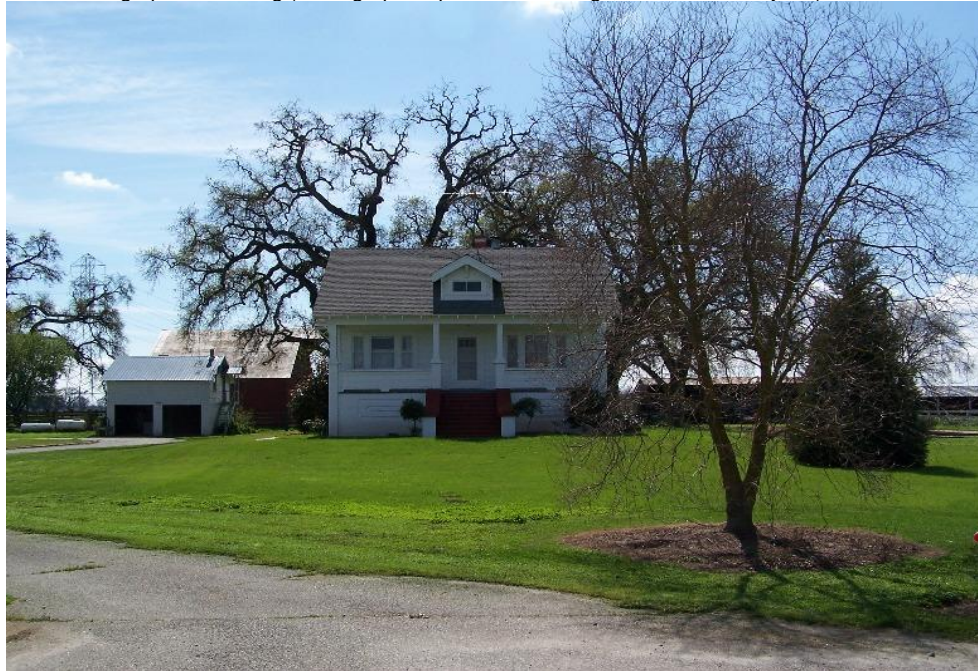
P5b. Description of Photo: (view, date, accession #) View looking west at the façade, July 18, 2006

The condition of the building is excellent. Alterations include some replacement windows.

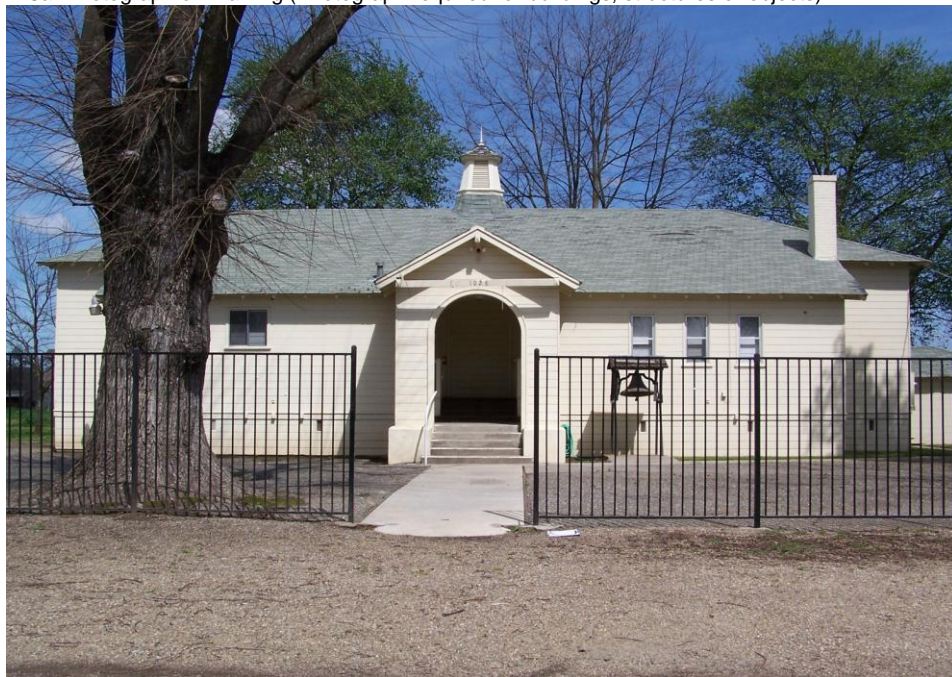
P5b. Description of Photo: (view, date, accession #) View looking west at the façade, July 18, 2006

Alterations to the building include replacement of the windows and conversion of the building into a church. The condition of the building is good.

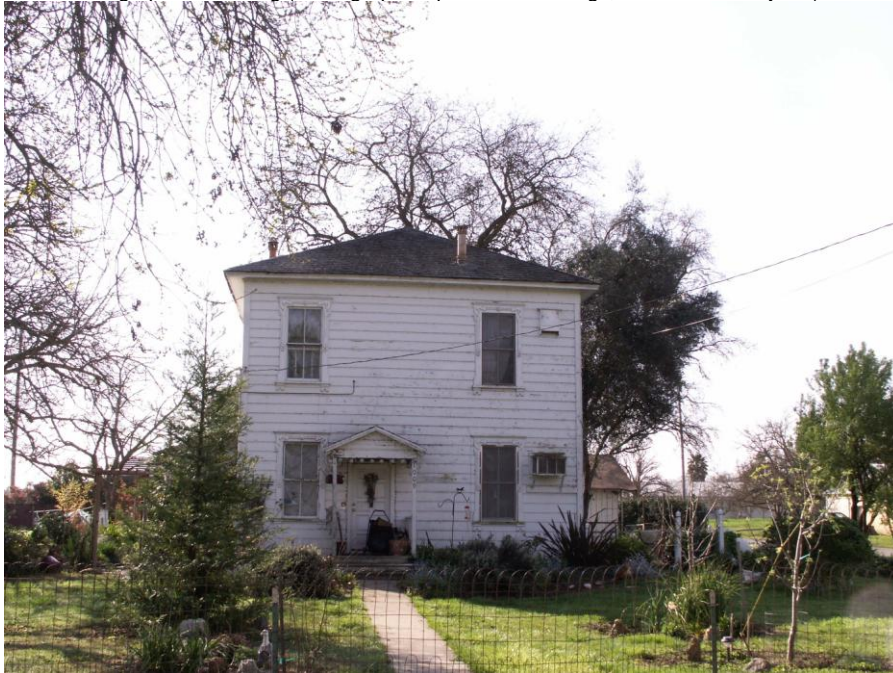
P5b. Description of Photo: (view, date, accession #) View looking south at the façade, July 18, 2006

The condition of the building is fair. Alterations to the building include a one-story shed roof addition to the east elevation that wraps around to the rear. This early addition's roof is clad in metal sheets. The addition has horizontal and vertical wood boards. Some windows have been replaced.

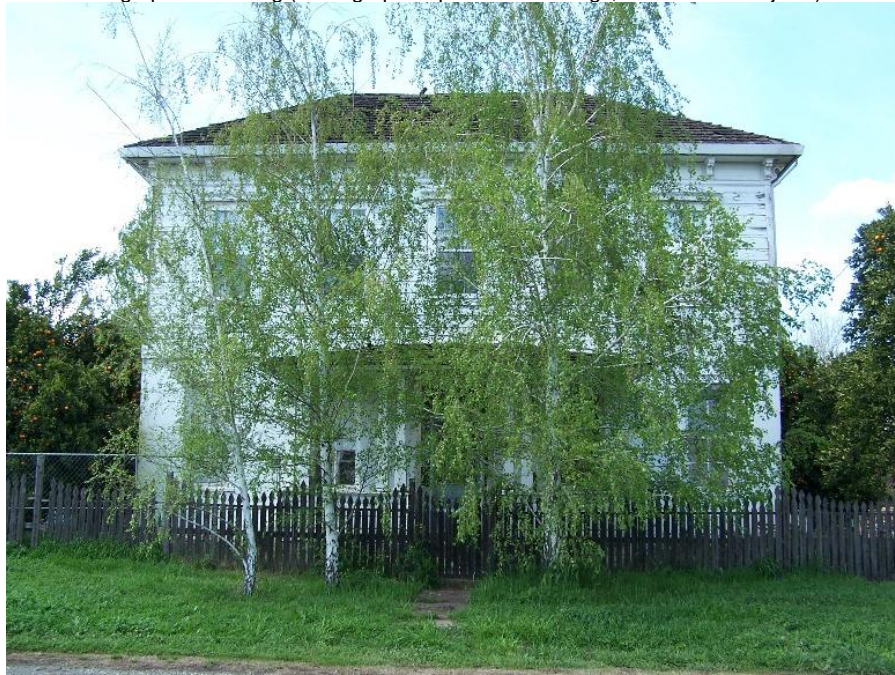
P5b. Description of Photo: (view, date, accession #) View looking north at the façade, July 18, 2006

Alterations to the building include replacement of the second story windows, removal of the first floor horizontal wood siding, removal of entry steps, and the possible addition to the north elevation. The condition of the building is poor.

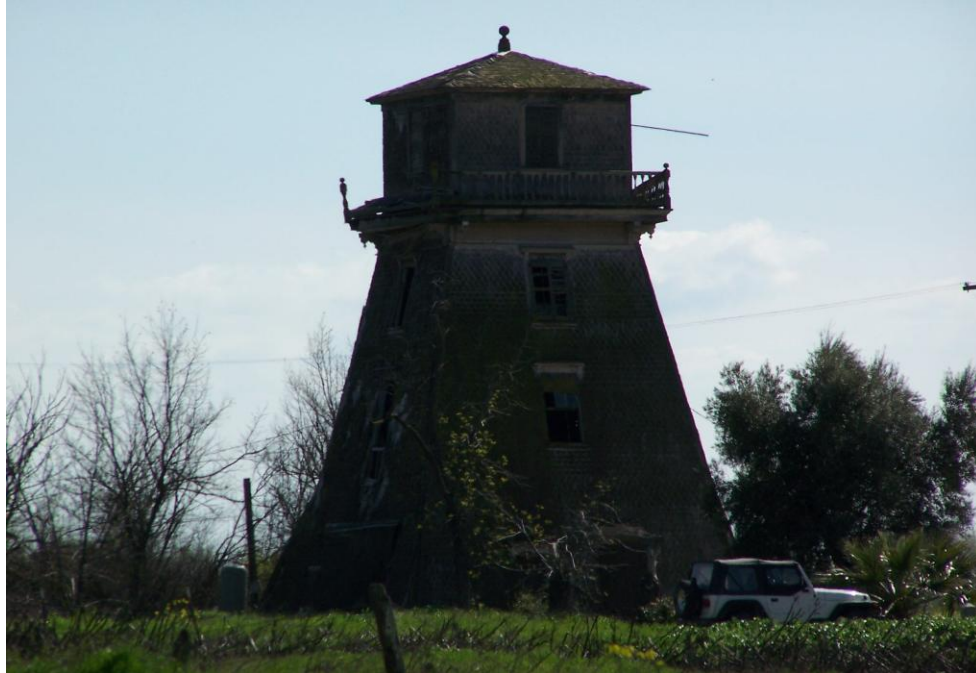
P5b. Description of Photo: (view, date, accession #) View looking west at the façade, July 18, 2006

Alterations to the building include replacement of wood shingles on the south elevation. The condition of the building is poor.

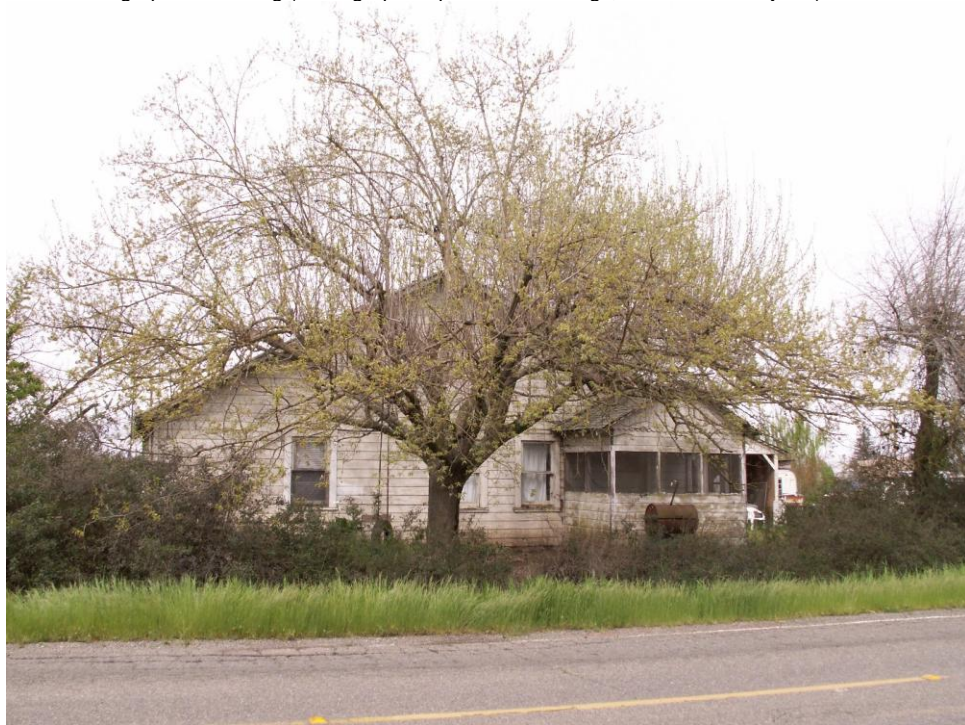
P5b. Description of Photo: (view, date, accession #) View looking east at the façade, July 18, 2006

Alterations to the building include addition of the enclosed porch. The condition of the building is fair to poor.

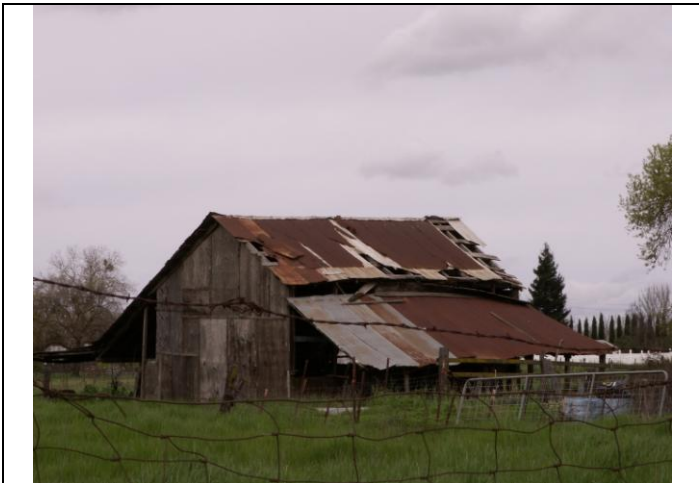
View looking at the barn to the rear of the property

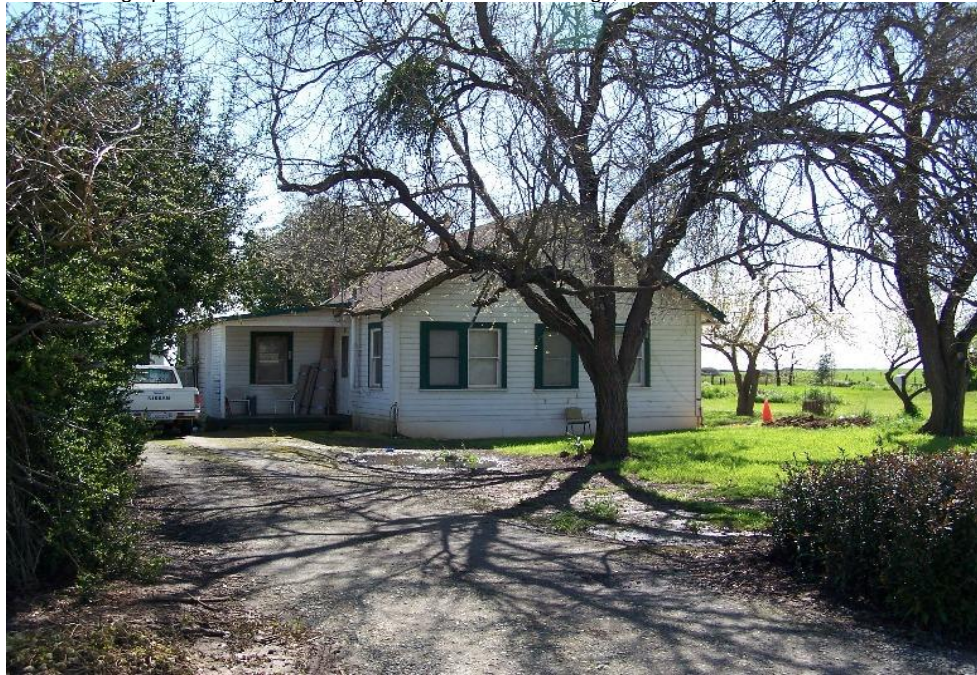
P5b. Description of Photo: (view, date, accession #) View looking east at the façade, July 18, 2006

Alterations to the building include a possible addition to the north elevation. The condition of the building is good to fair.

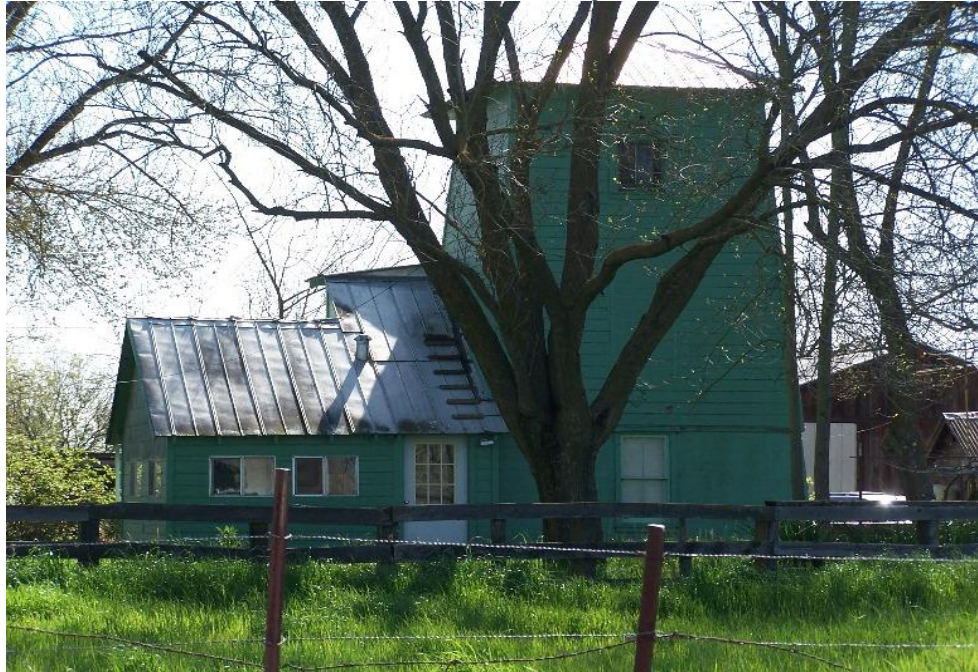
P5b. Description of Photo: (view, date, accession #) View looking east at the façade, July 18, 2006

Alterations to the building include the additions to the north and east elevations. The condition of the building is good.

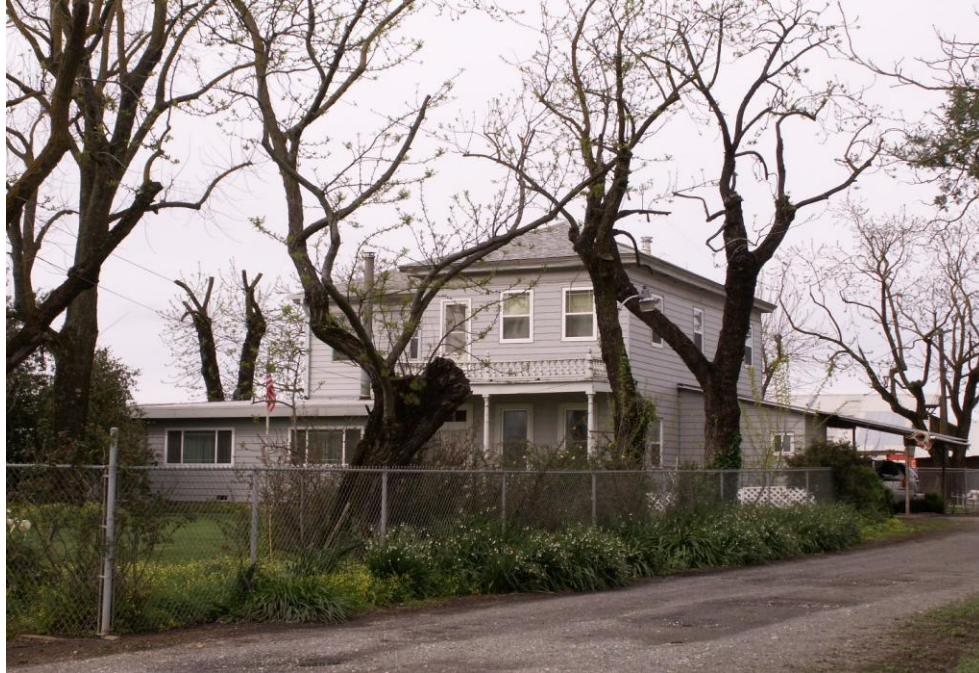
P5b. Description of Photo: (view, date, accession #) View looking west at the façade, July 18, 2006

Alterations to the building include a major addition to the house, perhaps doubling its size, and replacement windows. The original section of the residence is identified where the windows are both taller and narrower than the modern replacement windows. The condition of the building is good.

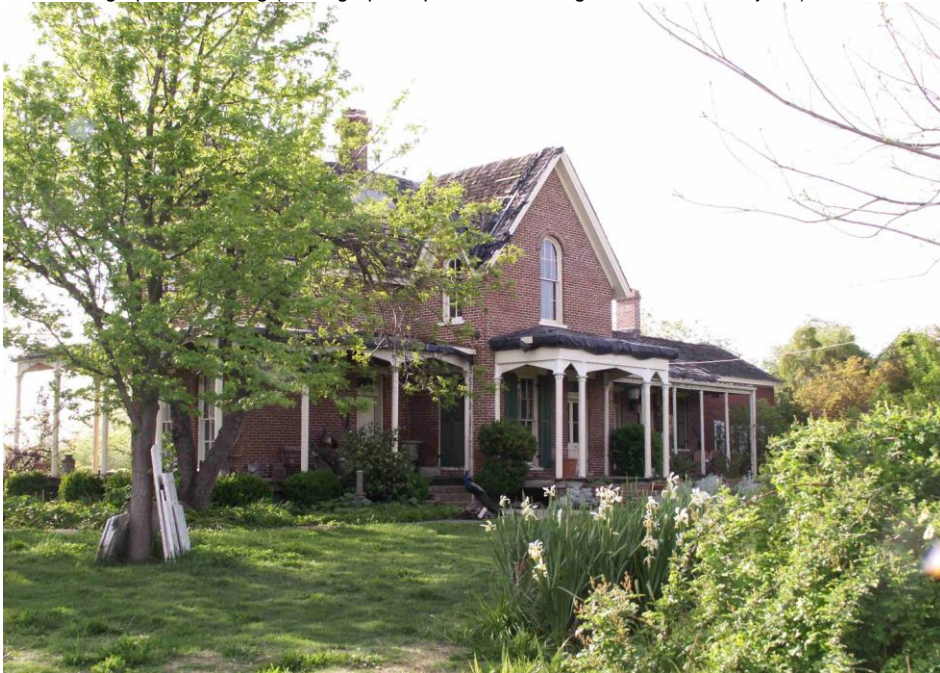
P5b. Description of Photo: (view, date, accession #) View looking northwest at the façade, April 21, 2006

Alterations to the building include an addition made to the north elevation of the residence. The condition of the building is good.

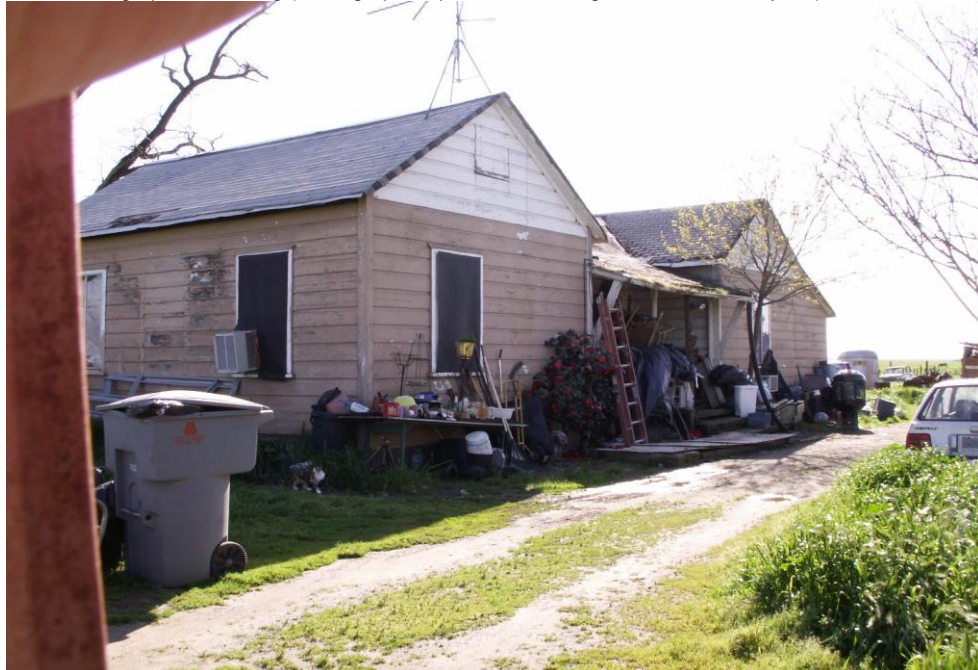
P5b. Description of Photo: (view, date, accession #) View looking southwest at the façade, July 18, 2006

No alterations are evident. The condition of the property is fair to poor.

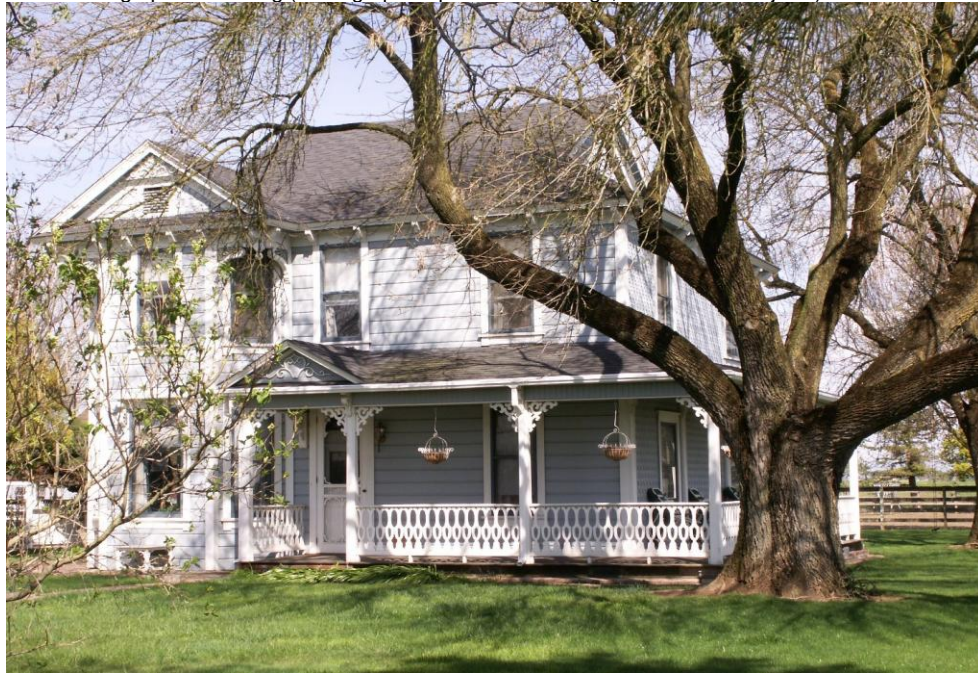
P5b. Description of Photo: (view, date, accession #) View looking east at the façade, July 18, 2006

Alterations to the building may include some of the decorative details. The condition of the building is excellent.

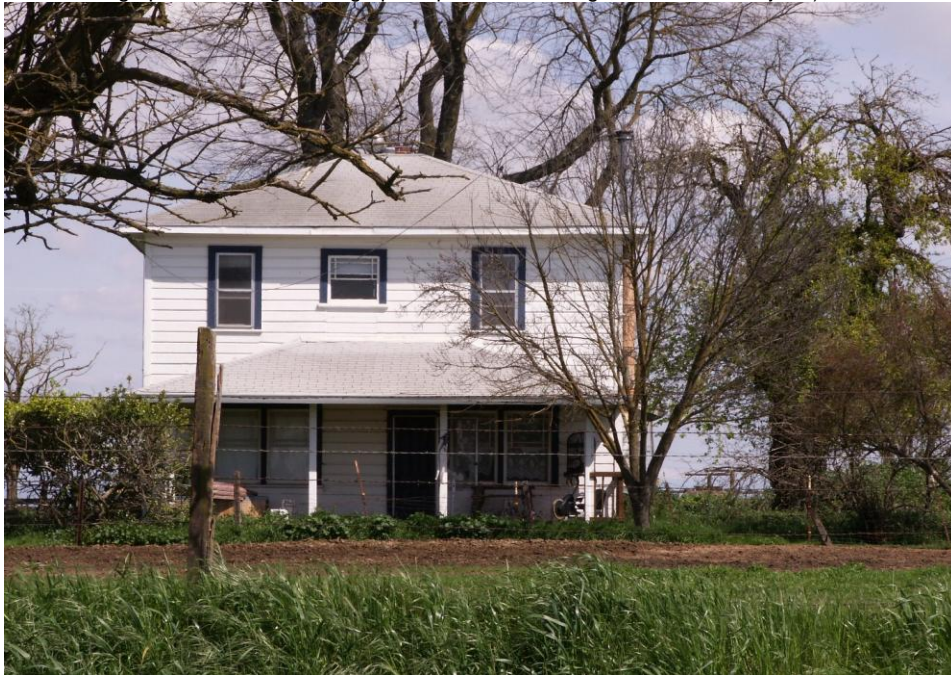
P5b. Description of Photo: (view, date, accession #) View looking east at the façade, July 18, 2006

Alterations to the building include some of the replaced windows, including two at the façade. The condition of the building is good.

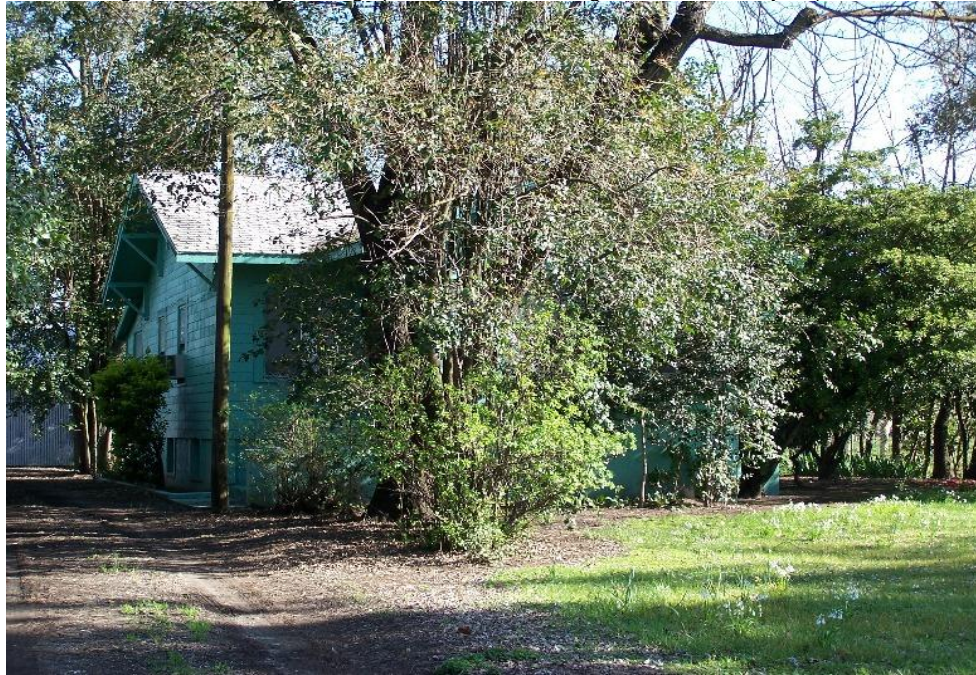
P5b. Description of Photo: (view, date, accession #) View looking north at the façade, July 18, 2006

Alterations to the building include replacement of the façade windows and the enclosing of the porch. The condition of the building is good.
