PRIMARY RECORD

*Resource Name or # (Assigned by recorder) 200 Bridge Street, Yuba City

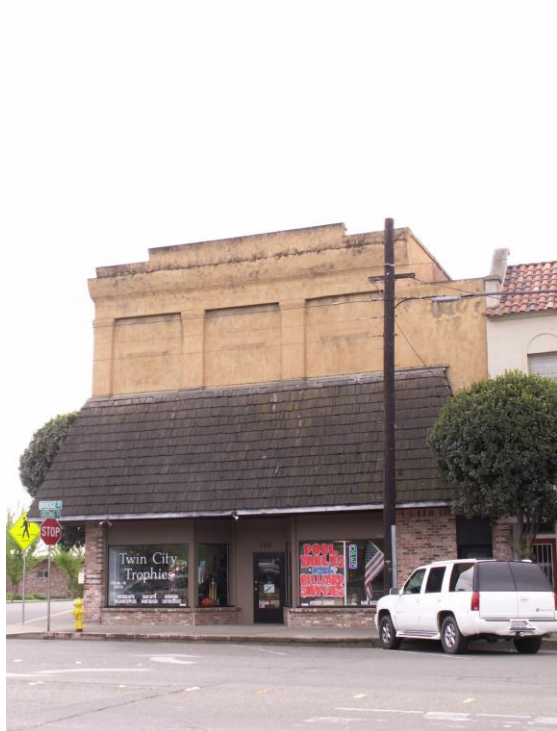
P5b. Description of Photo: (view, date, accession #) View looking south at the façade, April 18, 2006

The building was extensively remodeled in the circa 1970s, with the addition of stucco and brick cladding at the primary elevations. The storefronts were also reconfigured and remodeled. The condition of the building is good.

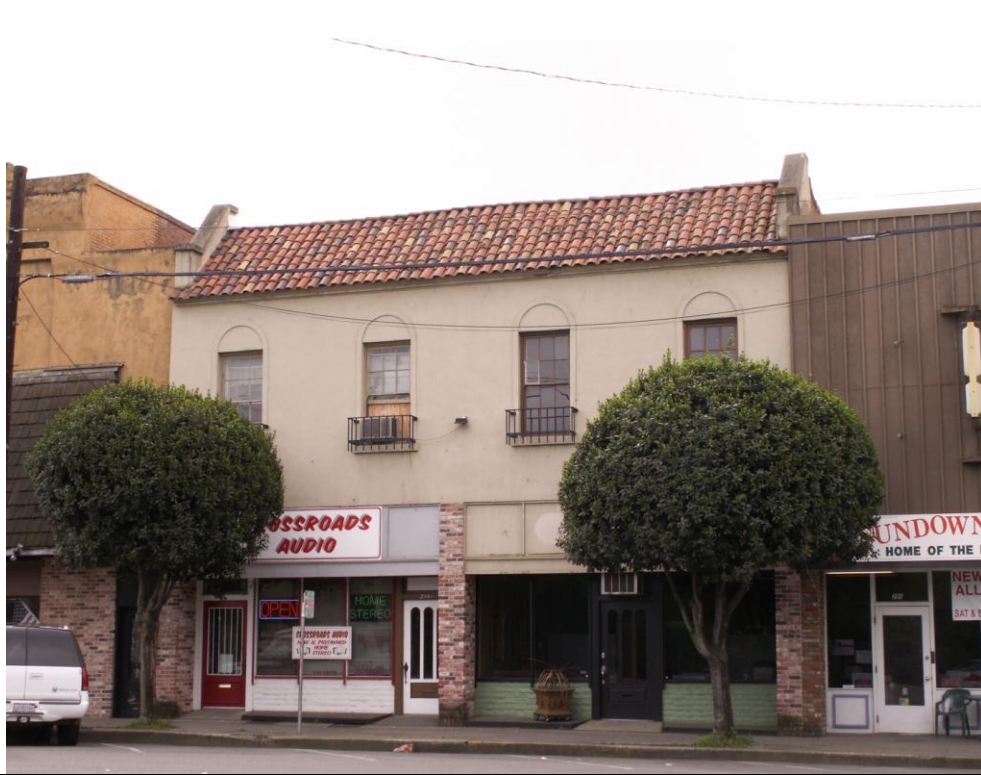
P5b. Description of Photo: (view, date, accession #) View looking southeast at the façade, April 18, 2006

Alterations include the early remodeling of the façade, likely during the circa 1920s. The storefronts were then further remodeled, likely during the 1970s or 1980s. The original door and windows at the rear of the building have been replaced. The condition of the building is good.

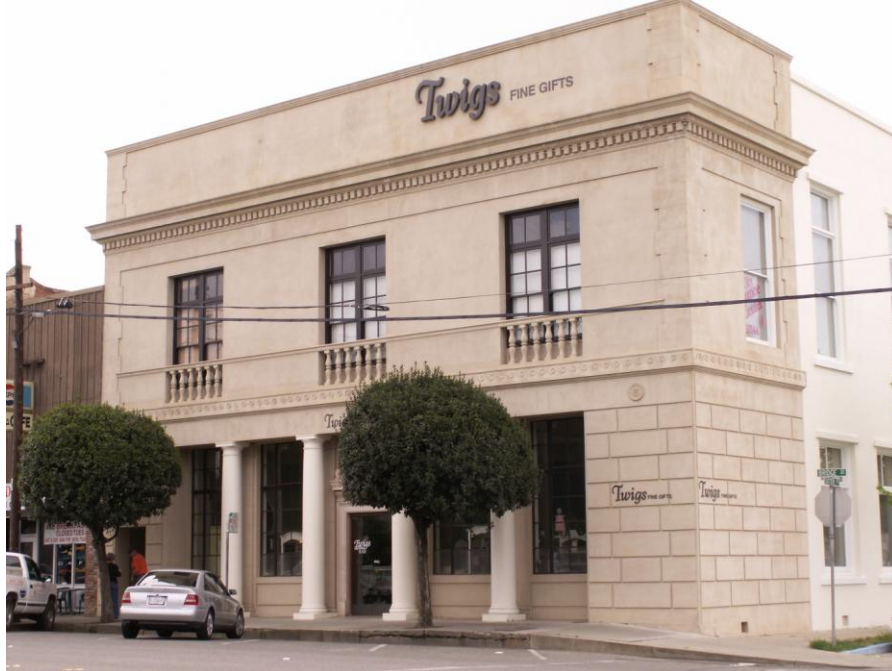
P5b. Description of Photo: (view, date, accession #) View looking southeast at the façade, April 18, 2006

The façade has been recently extensively remodeled with the addition of classical details. The stucco cladding of the rest of the elevations is also newer. The condition of the building is good.

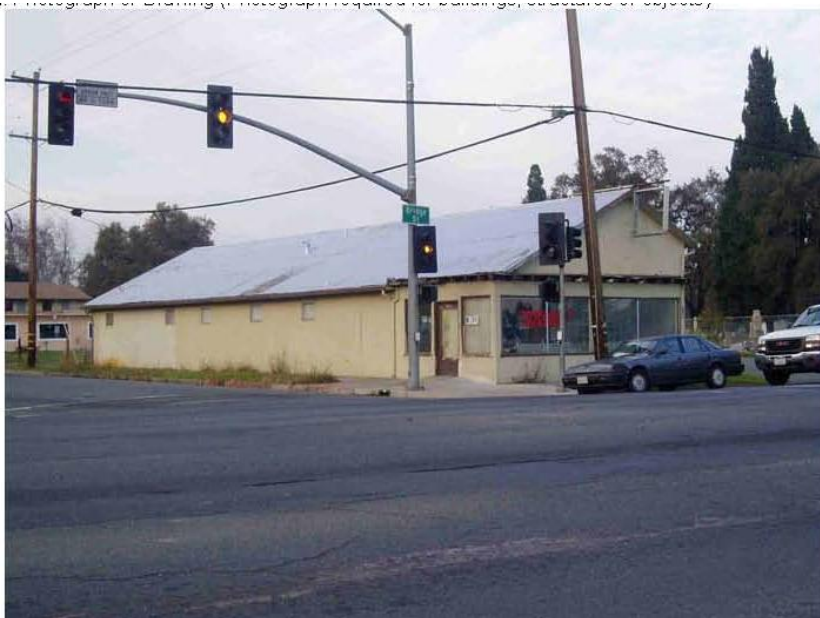
There is an asphalt driveway that runs along the east side of the building. There are no ancillary buildings on this property. Alterations include the enclosure of the northeast wall, replacement of the windows on the façade, and cladding of the exterior in smooth stucco. The condition of the building is fair to poor.

P5b. Description of Photo: (view, date, accession #) View looking north at the façade and southwest elevation December 12, 2005

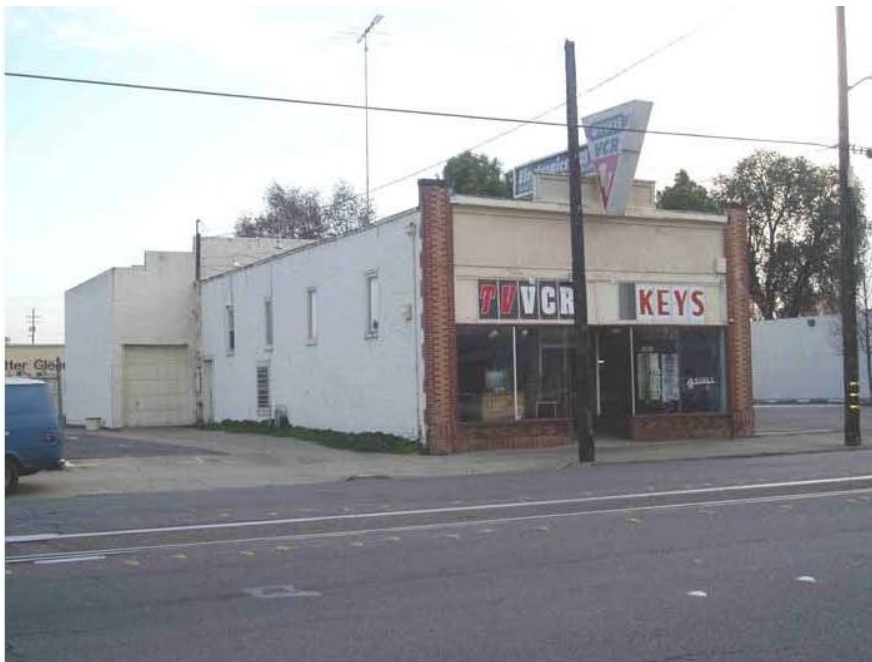
P5b. Description of Photo: (view, date, accession #) View looking south at the northwest facing façade and the northeast elevation, December 12, 2005

The overall integrity of the building is fair. The condition of the building is fair.

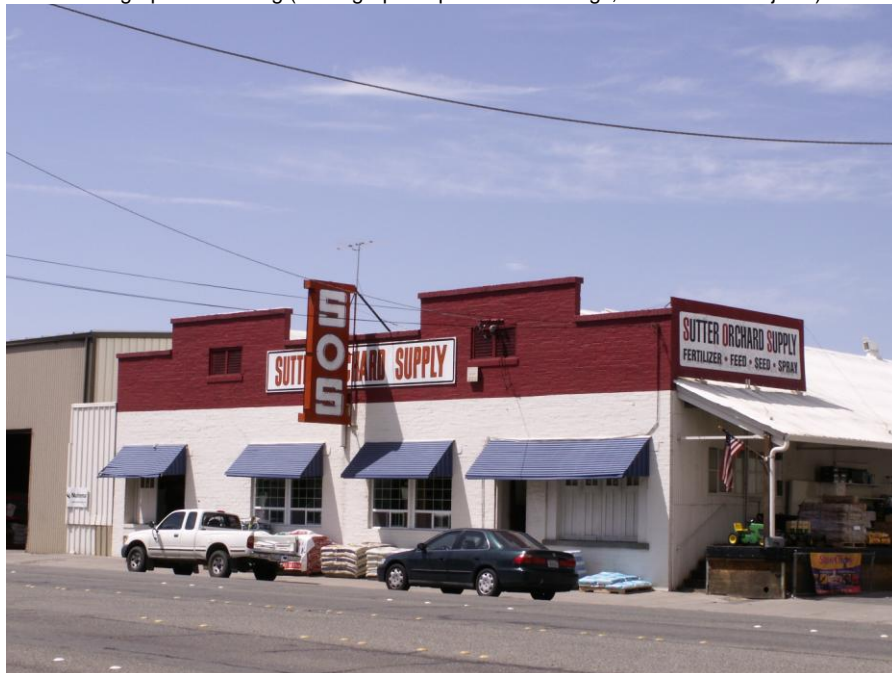
P5b. Description of Photo: (view, date, accession #) View looking northwest at the façade, April 18, 2006

Alterations to the building include the removal of the original windows and addition of metal awnings over the windows. The condition of the building is good.

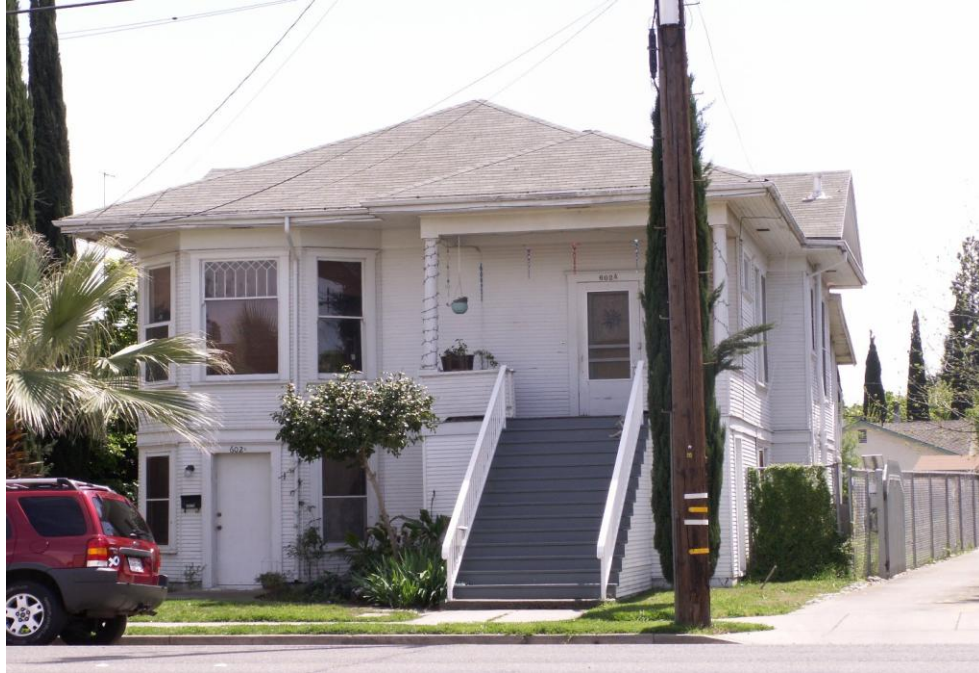
P5b. Description of Photo: (view, date, accession #) View facing southeast at the façade, April 21, 2006

Alterations to the building include new steps and handrails. The condition of the building is good.

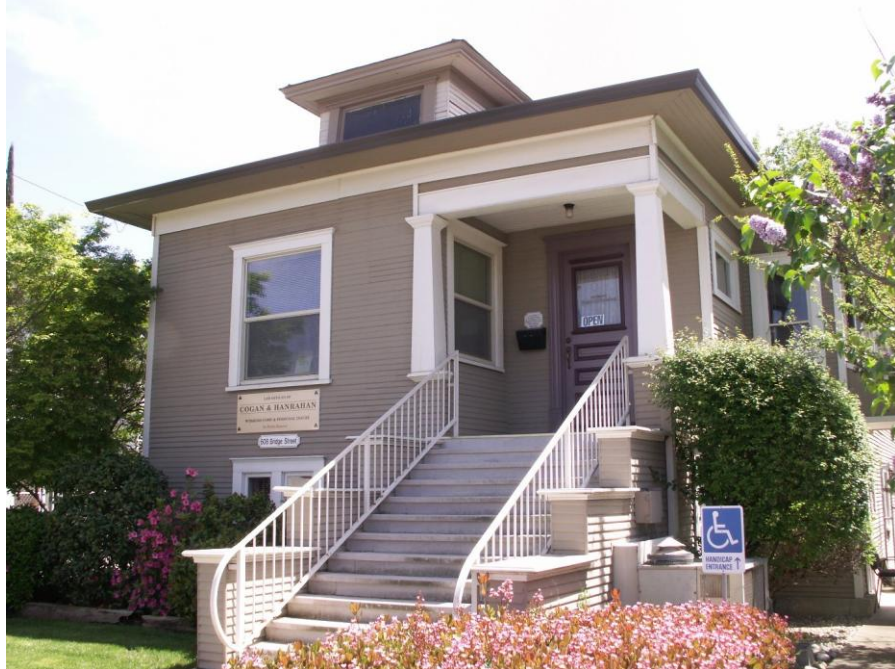
P5b. Description of Photo: (view, date, accession #) View looking southeast at the façade, April 21, 2006

The steps, handrails and some of the windows have been replaced. The condition of the building is excellent to good.

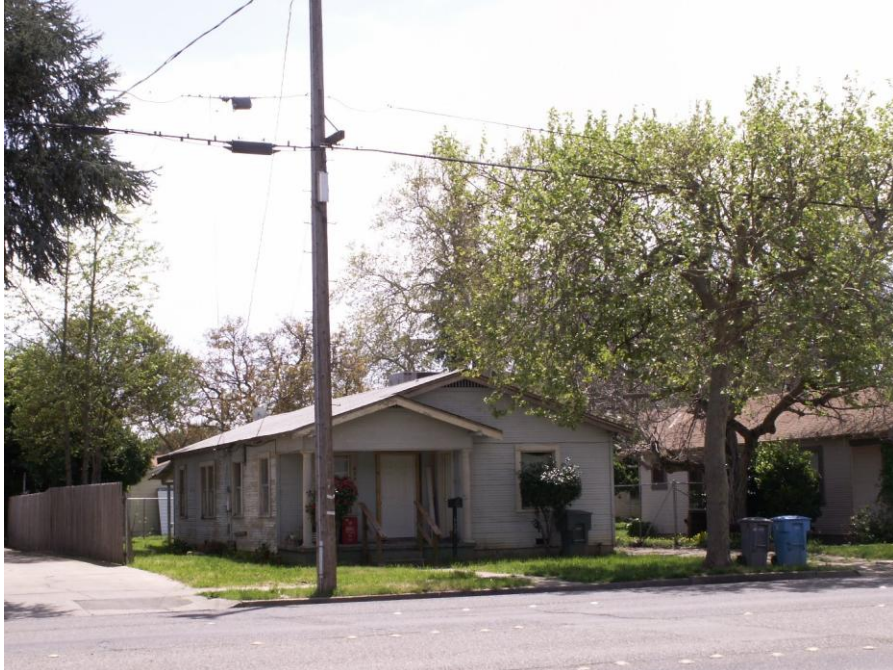
P5b. Description of Photo: (view, date, accession #) View looking southwest at the façade, July 14, 2006

Alterations to the building include window replacements, a filled-in window opening, and non-original handrails and door at the front porch. The garage doors have been replaced. The condition of the building is fair.

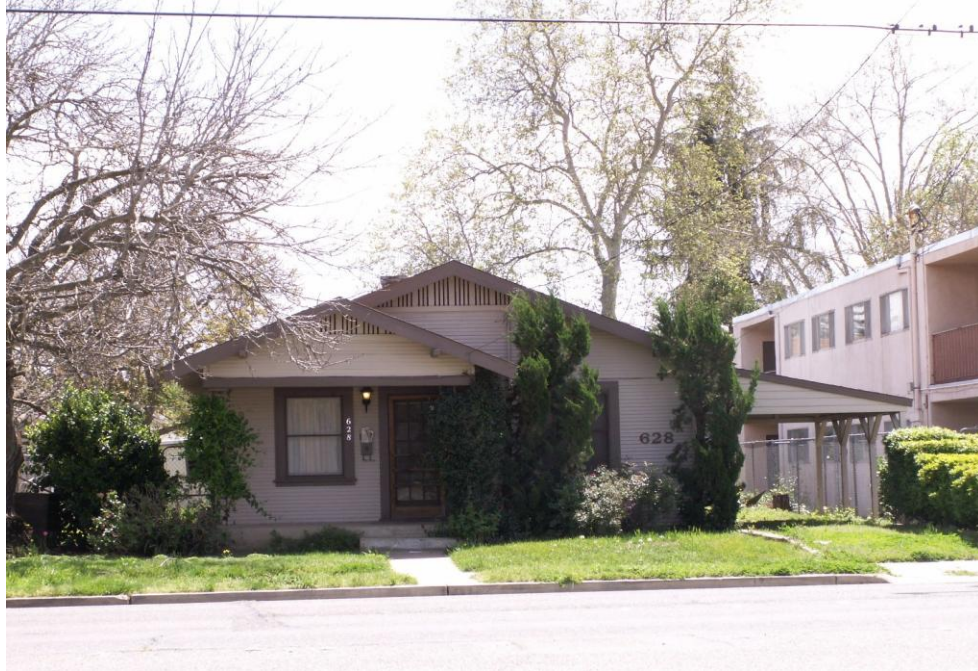
P5b. Description of Photo: (view, date, accession #) View looking south at the façade, July 18, 2006

Alterations to the building include the addition of a porte-cochere and the replacement of the porch supports. The front door and porch light are also not original. The condition of the building is good.

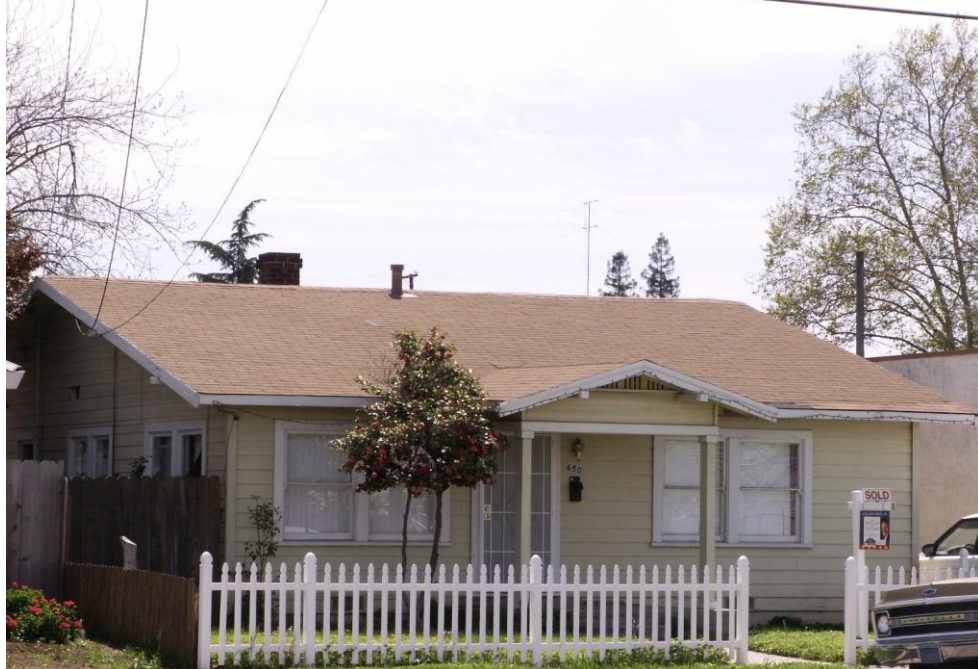
P5b. Description of Photo: (view, date, accession #) View looking southwest at the façade, July 14, 2006

The security door and picket fence are not original. The condition of the building is good.

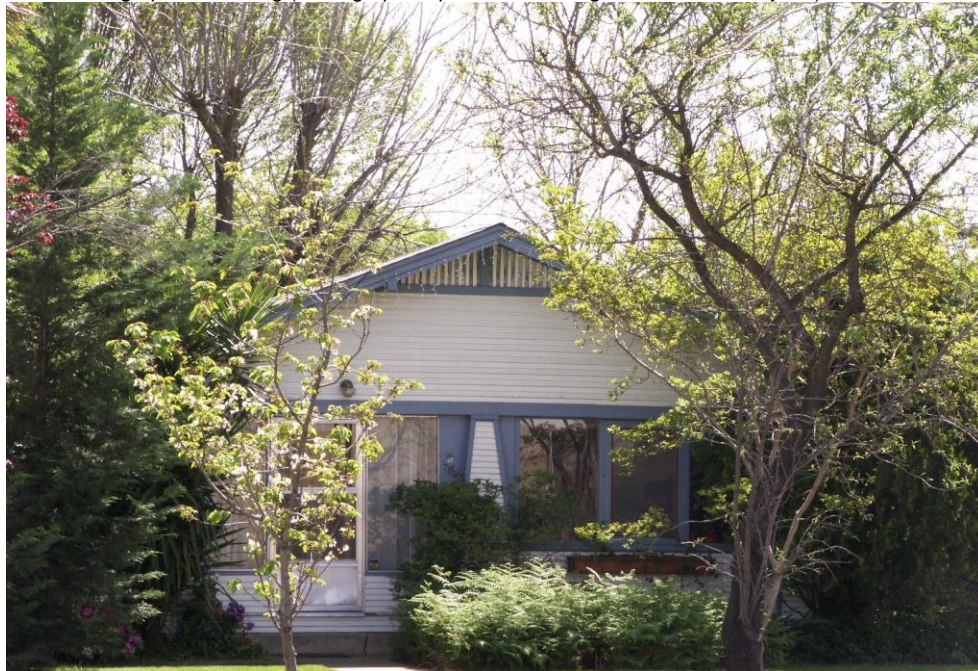
P5b. Description of Photo: (view, date, accession #) View looking south at the façade, July 18, 2006

Alterations to the building include the early enclosure of the front porch. The condition of the building is good.

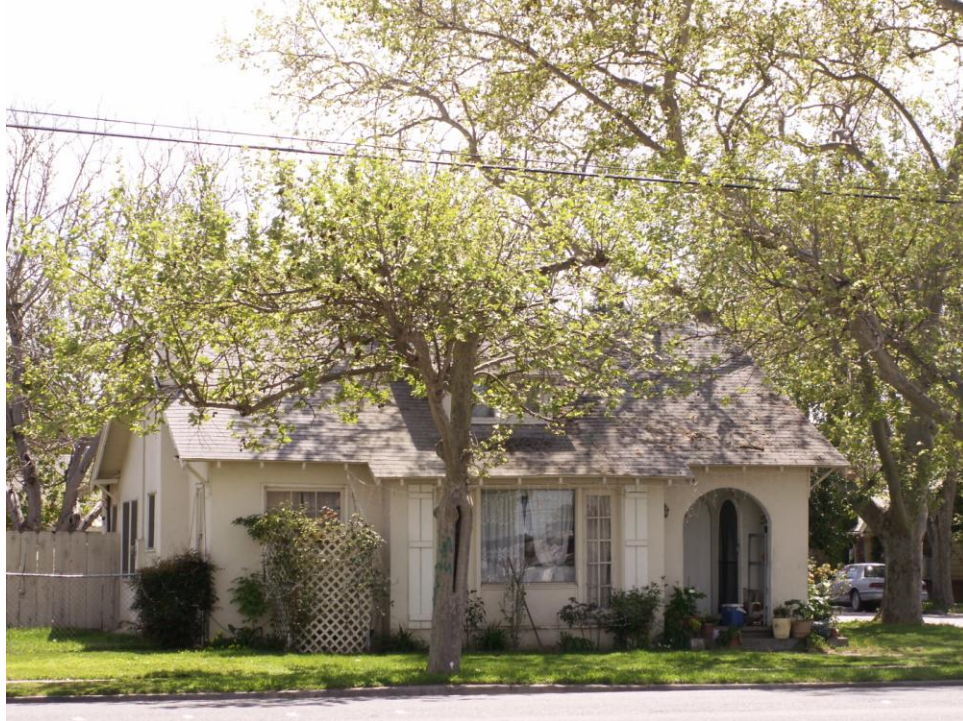
P5b. Description of Photo: (view, date, accession #) View looking southwest at the façade, July 18, 2006

Alterations to the building include modifications from the Craftsman style. The exterior was likely reclad with stucco, and the porch and façade windows were reconfigured in the circa 1930s. None of the façade porch and window materials are original. The condition of the building is good.

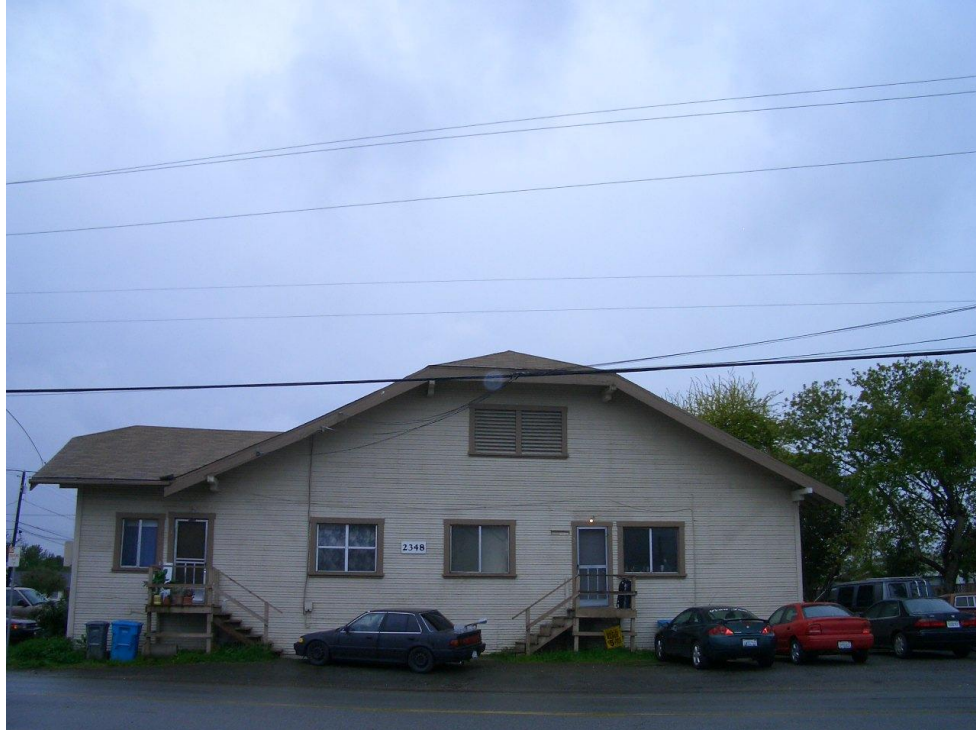
P5b. Description of Photo: (view, date, accession #) View looking south at the façade, July 14, 2006

Alterations to the building include the replacement of most of the windows, and five of the six entry primary doors. The basement door also appears to have been replaced. The condition of the building is good to fair.

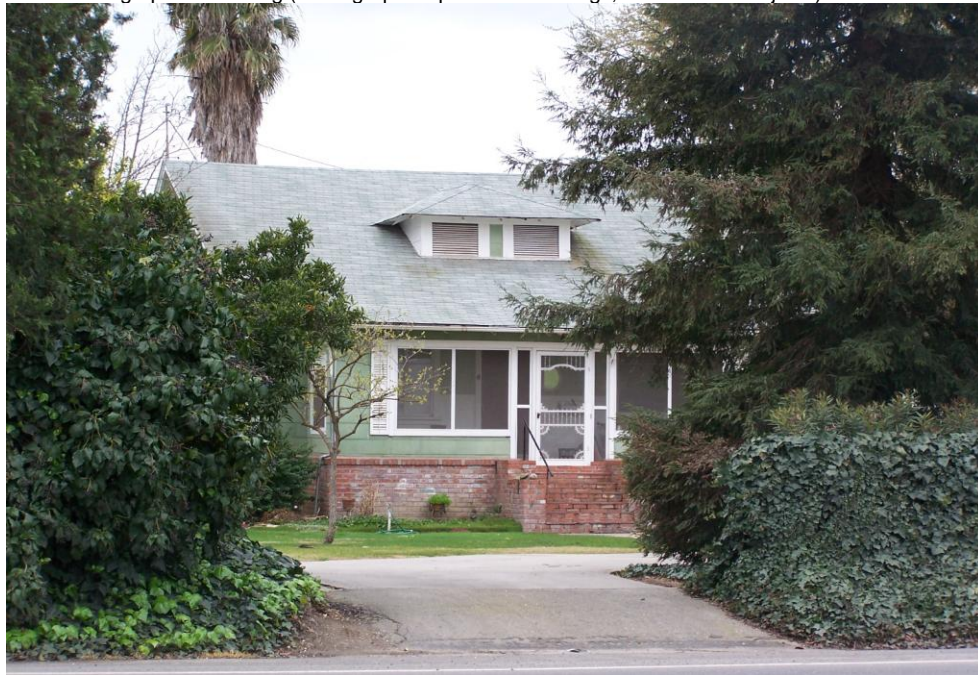
P5b. Description of Photo: (view, date, accession #) View looking south at the façade, July 14, 2006

Alterations to the building include the replacement asbestos siding, brick veneer and steps, early enclosure of the screen porch, and replacement of the dormer windows with vents. The condition of the building is good.

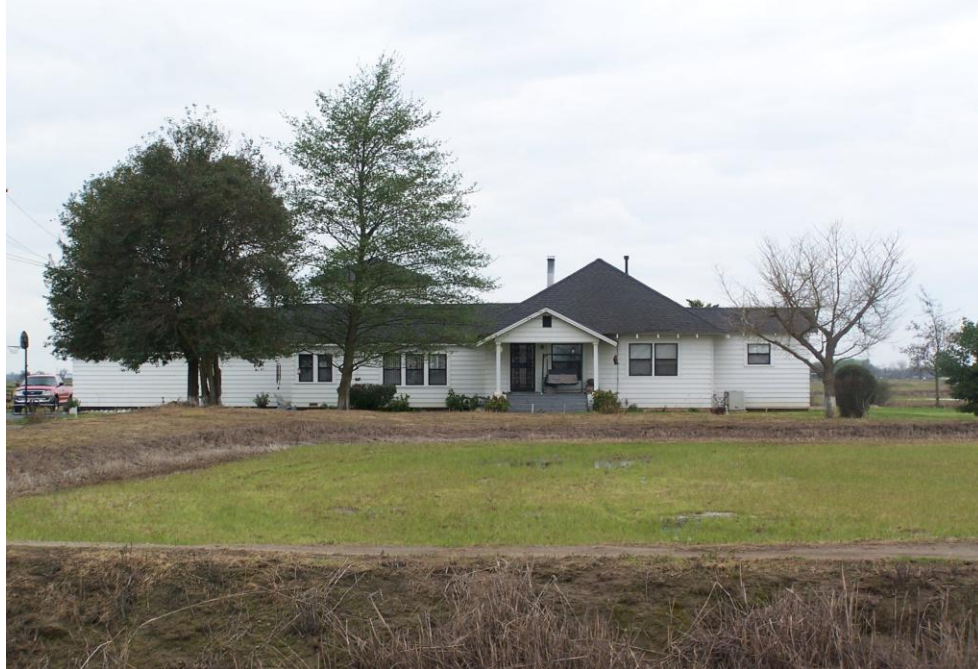
P5b. Description of Photo: (view, date, accession #) View looking south at the façade, July 14, 2006

Alterations to the building include long additions to the east and west elevations, replacement windows and replacement siding. The condition of the building is excellent.

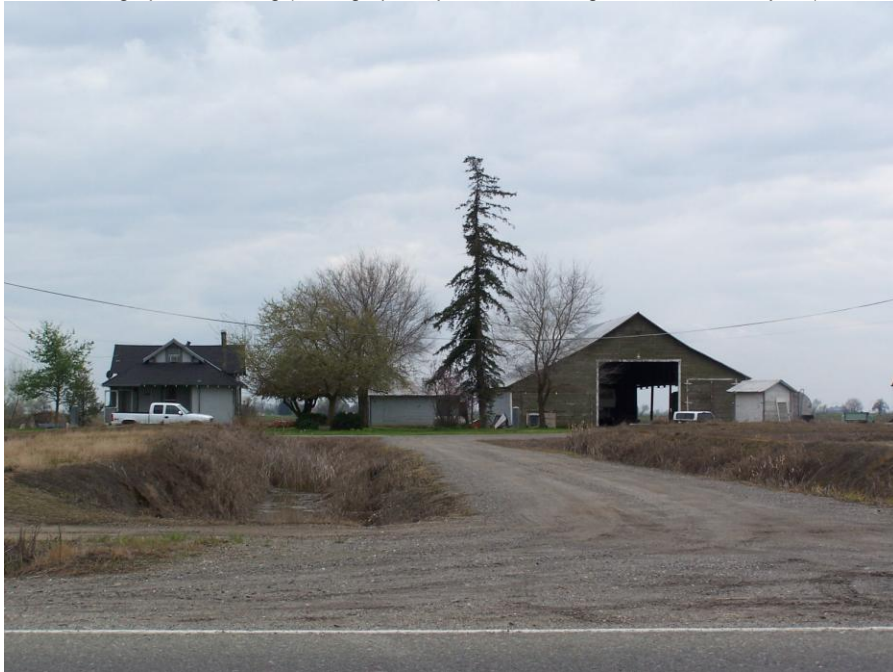
P5b. Description of Photo: (view, date, accession #) View looking south at the façade and the north elevation of the barn, July 14, 2006

Alterations to the building include replacement windows, the early addition of a room to the front porch enclosure (probably a bathroom), replacement of some of the balustrade of the porch, and carpeting added to the front porch landing. The condition of the building is good to fair.
