# PRIMARY RECORD

\*Resource Name or # (Assigned by recorder) 2600 Lincoln Road, Yuba City

P1. Other Identifier: Dahling house

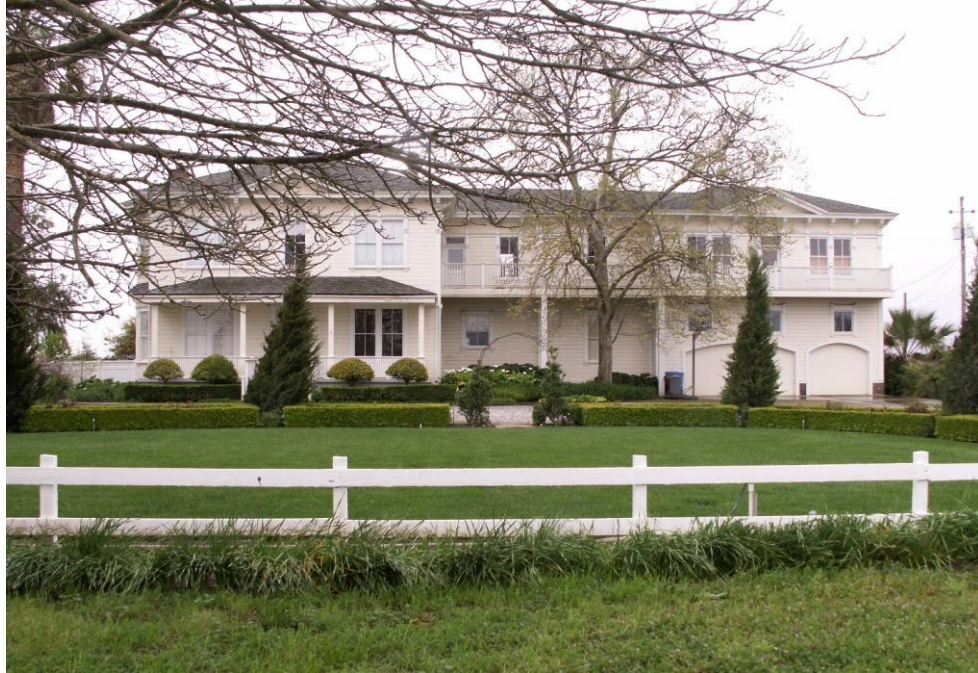
P5b. Description of Photo: (view, date, accession #) View looking south at the façade, July 18, 2006

The most significant alteration to the building is the addition of a significant size to the west. This includes a two-door garage and additional living quarters. It appears the east one-third of the residence is original. The porch is new and rebuilt. The condition of the building is excellent to good.

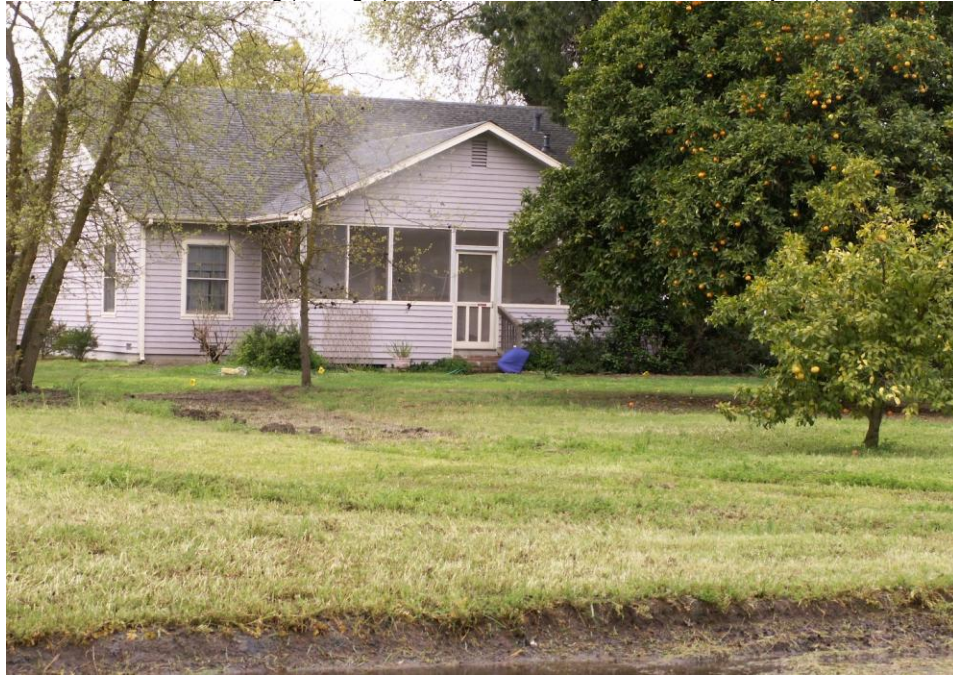
P5b. Description of Photo: (view, date, accession #) View looking south at the façade, July 18, 2006

Alterations to the building include the enclosing of the front porch. The condition of the building is good.

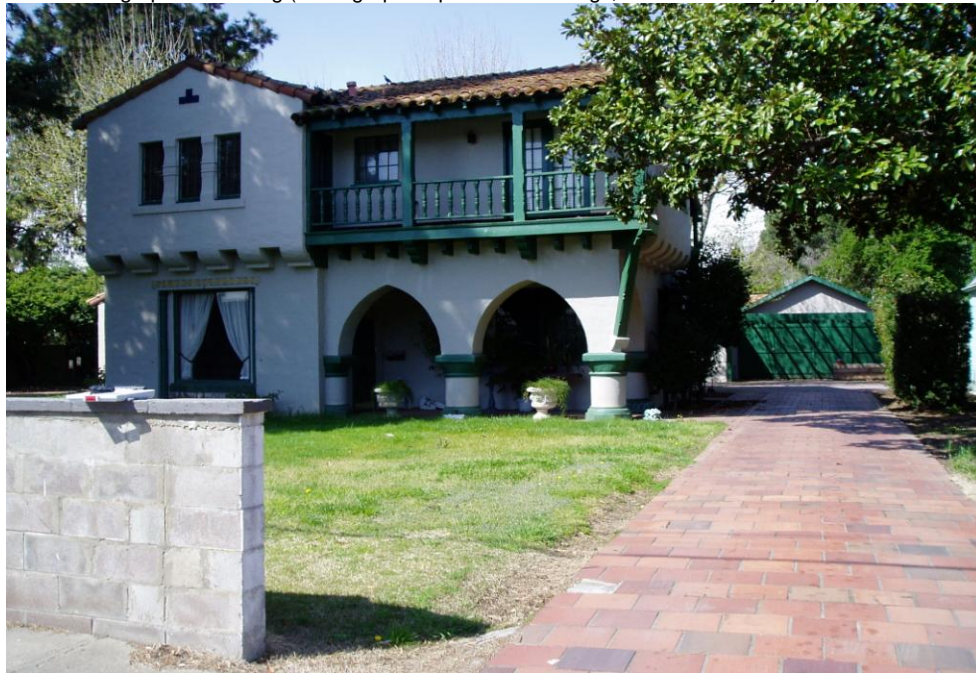
P5b. Description of Photo: (view, date, accession #) View looking west at the façade, July 18, 2006

Alterations to the building include the replacement of the secondary entrance door. The condition of the building is good to excellent.

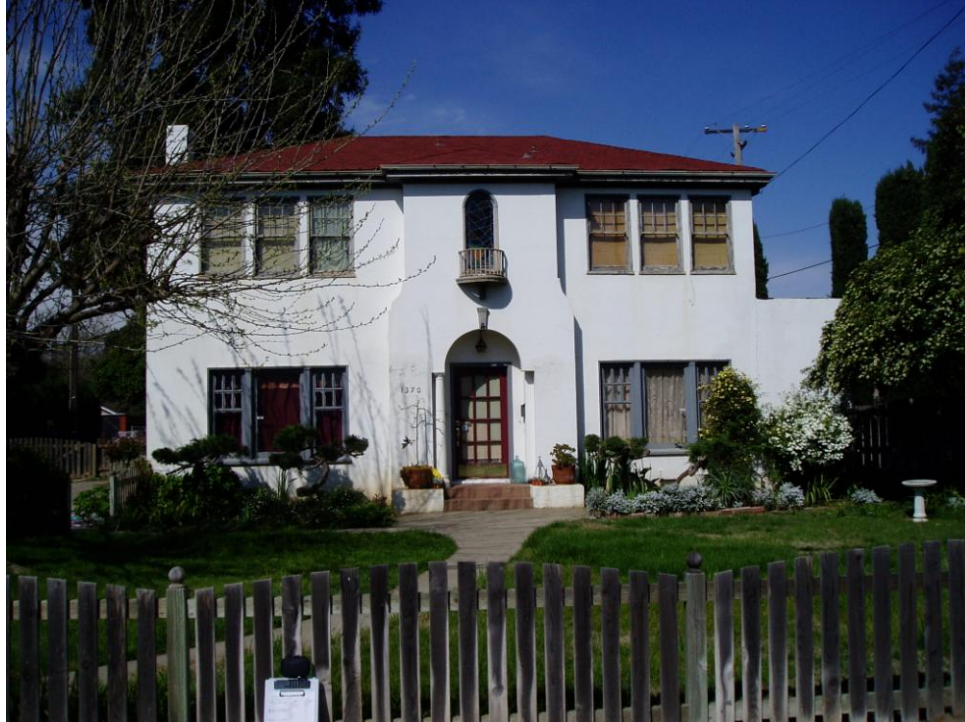
**P5b. Description of Photo:** (view, date, accession #) View looking west at the façade, July 18, 2006

Alterations to the building include an addition to the west elevation. The condition of the building is fair.

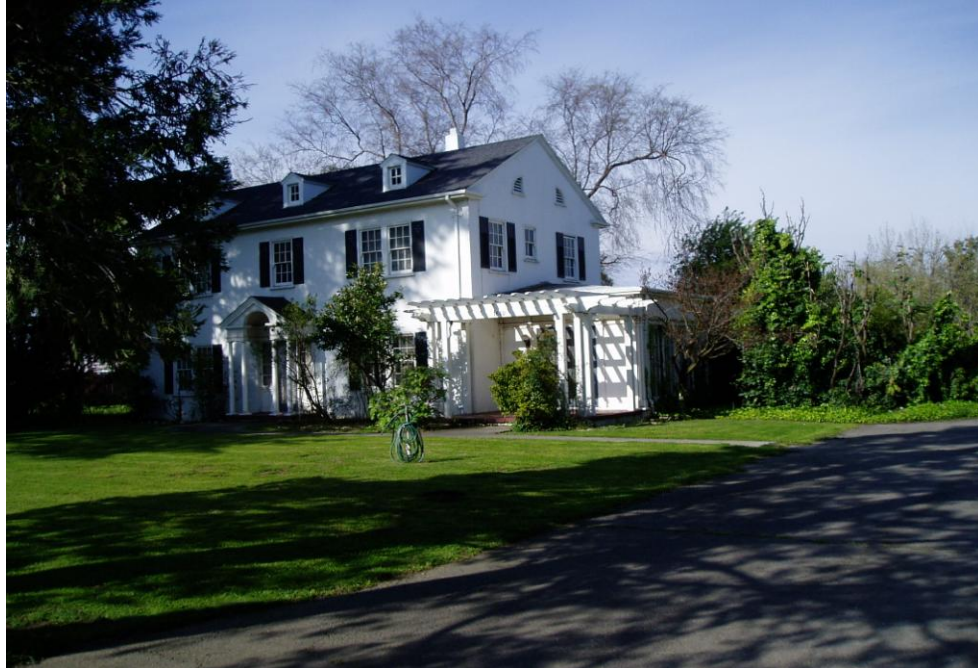
P5b. Description of Photo: (view, date, accession #) View looking southwest at the façade, July 18, 2006

The building does not appear to have been altered. The condition of the building is good.

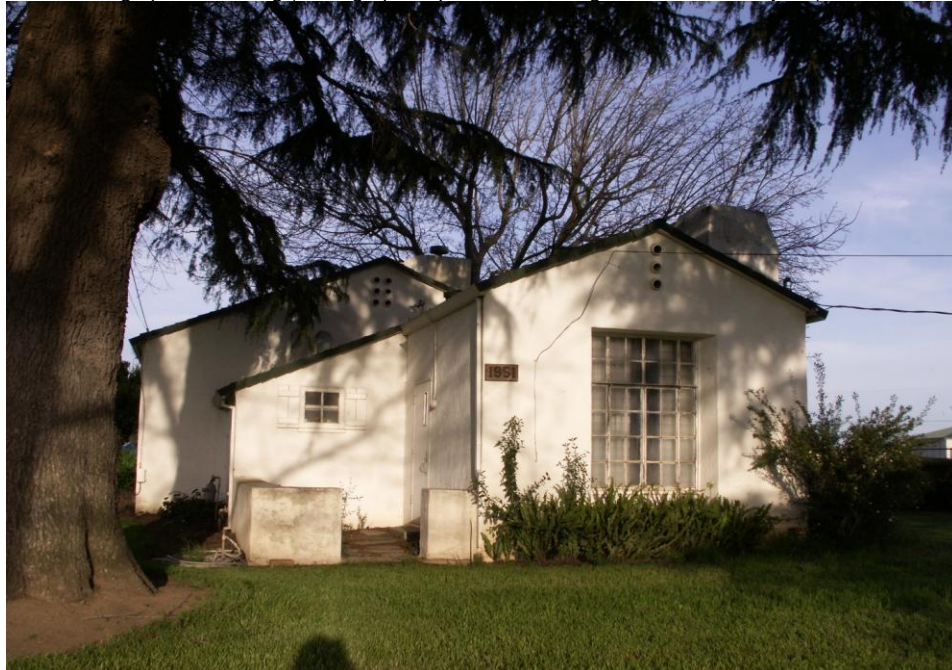
P5b. Description of Photo: (view, date, accession #) View looking east at the façade, July 18, 2006

Alterations to the building include the replacement of the original windows, doors and roofing materials. The condition of the building is fair.

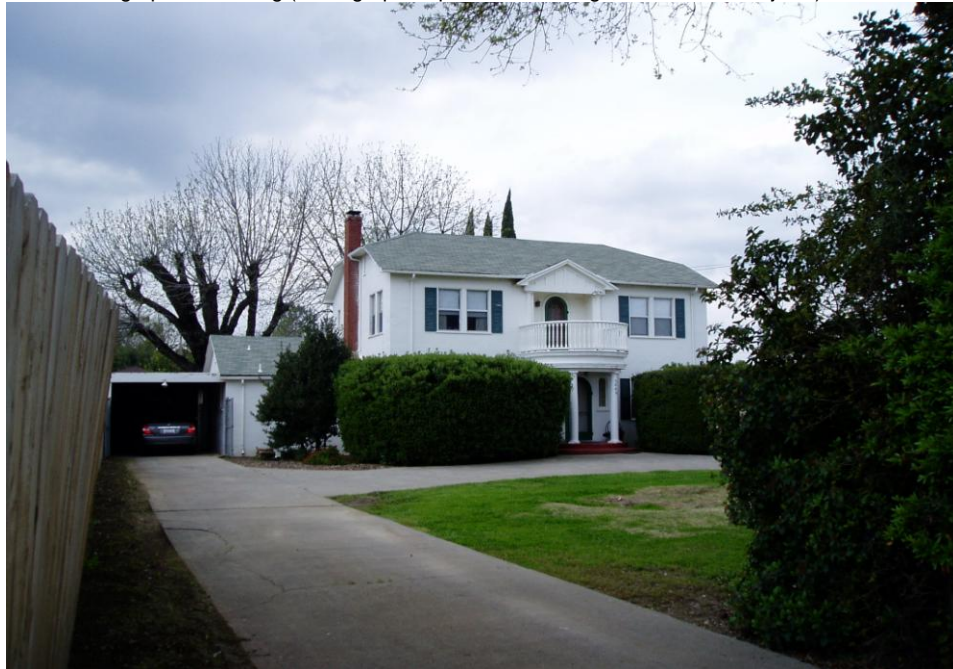
**P5b. Description of Photo:** (view, date, accession #) View looking west at the façade, July 18, 2006

Alterations to the building include the replacement of most of the windows. The condition of the building is good.

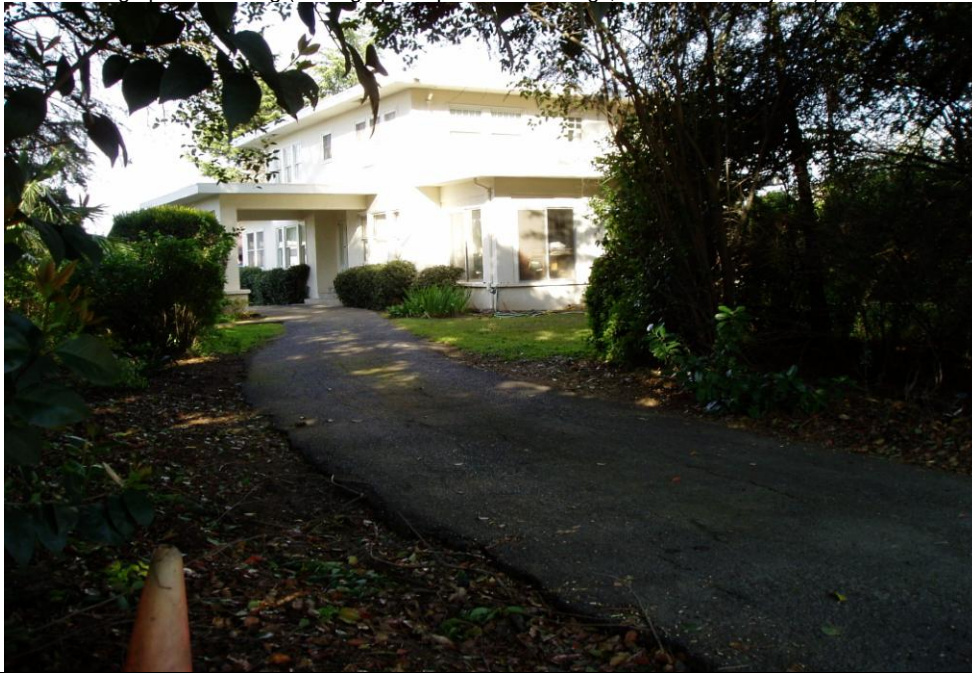
P5b. Description of Photo: (view, date, accession #) View looking south at the façade and north elevation, July 18, 2006

Alterations to the building include the enclosure of the façade porch. The condition of the building is good.

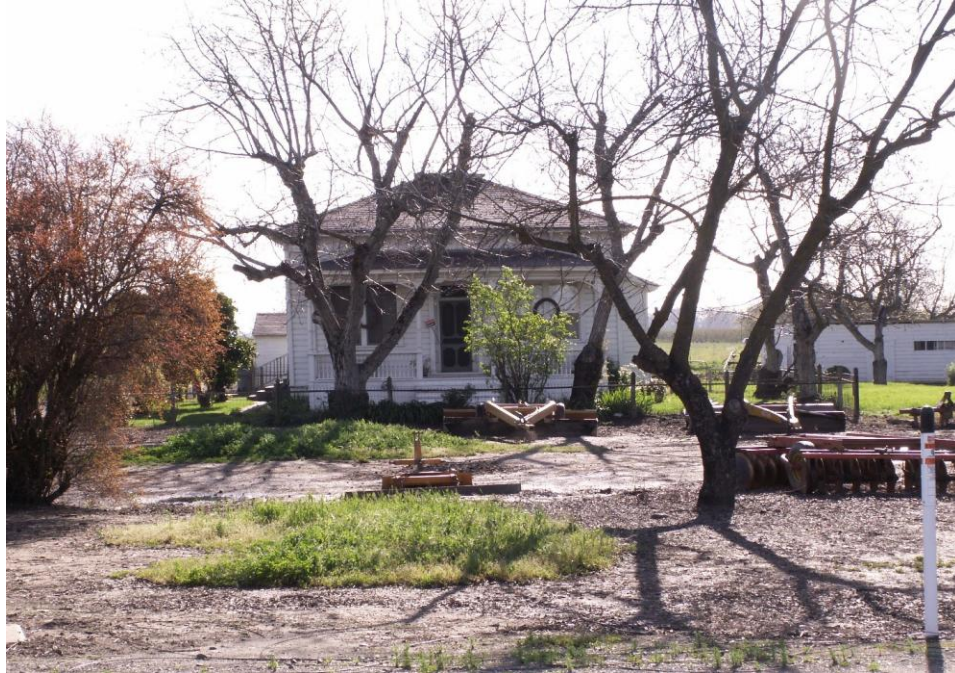
P5b. Description of Photo: (view, date, accession #) View looking east at the façade, July 18, 2006

The condition of the building is good to excellent. Alterations to the building include two additions at the rear of the building. The windows may be an early replacement. The current owner reports that her father bought the house in 1900 and turned it before adding a screened porch.

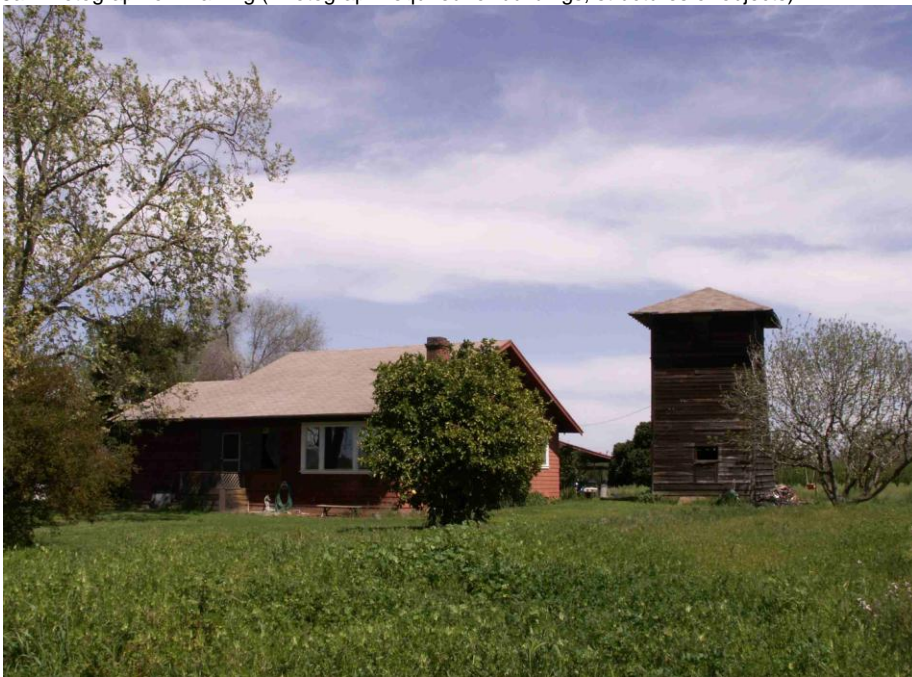
**P5b. Description of Photo:** (view, date, accession #) View looking northeast at the property, April 24, 2006

Alterations include the replacement of some of the original windows, replacement of the entry doors and the enclosure of the front porch. The condition of the building is good.

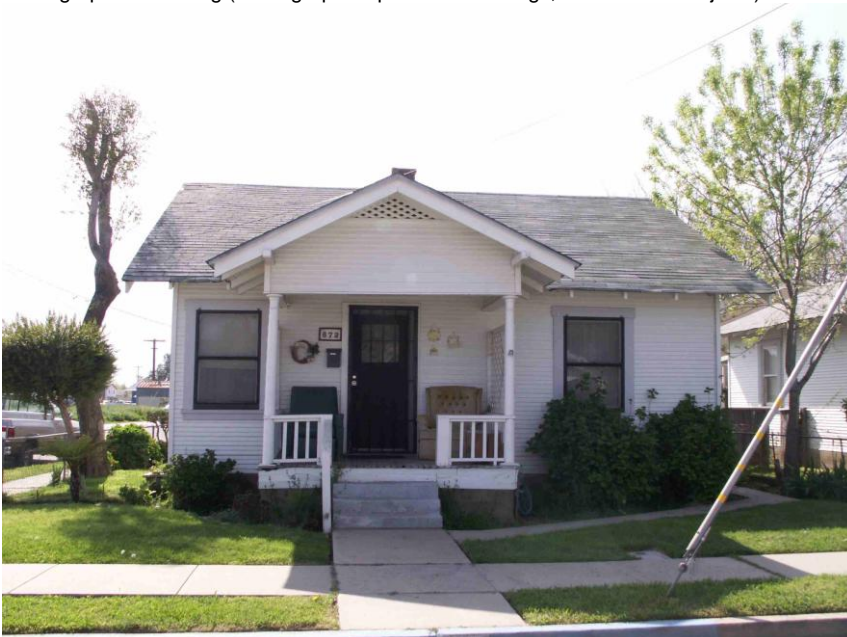
**P5b. Description of Photo:** (view, date, accession #) View looking west at the façade, April 24, 2006

Alterations to the building include the addition of lattice to the front porch. The condition of the building is good.

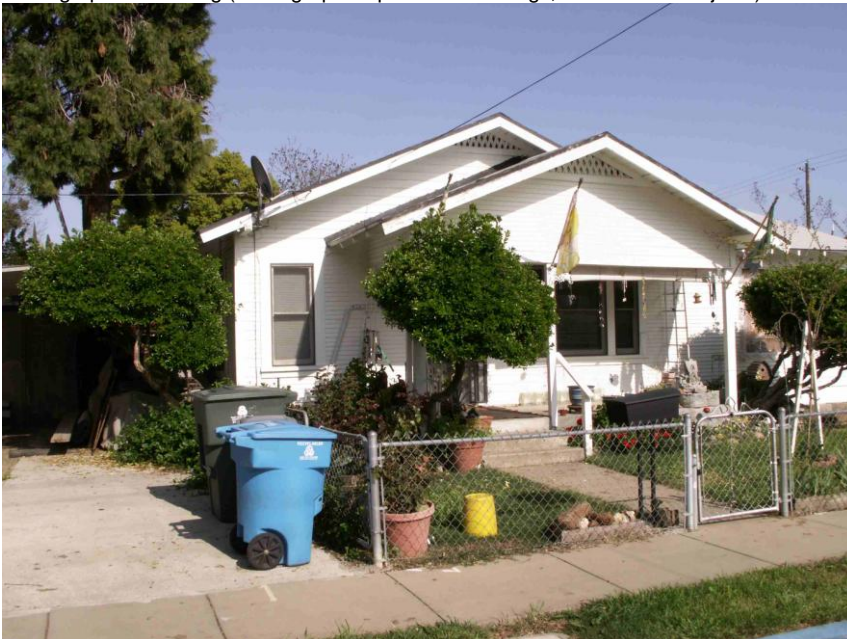
**P5b. Description of Photo:** (view, date, accession #) View looking southeast at the façade, April 24, 2006

Alterations to the building include the replacement of some of the windows. The condition of the building is good

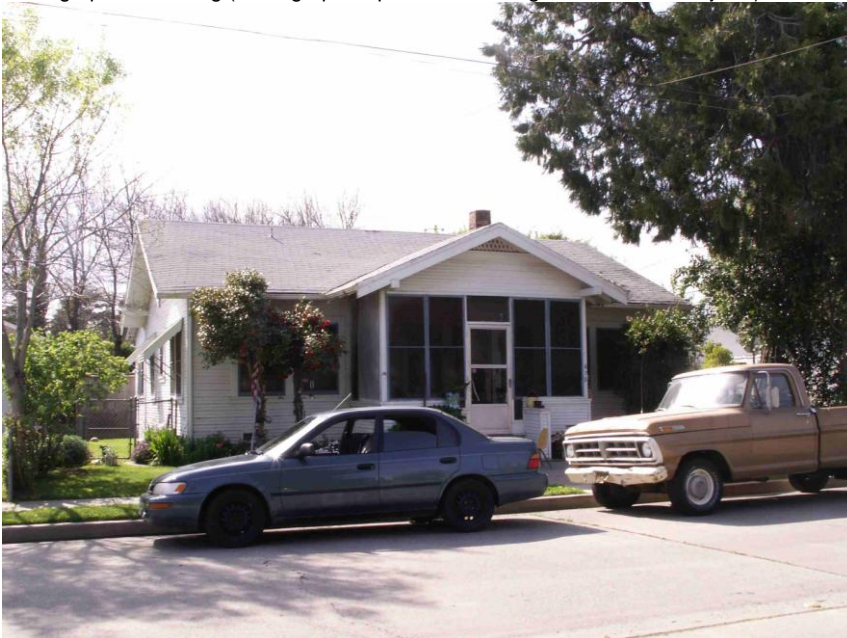
**P5b. Description of Photo:** (view, date, accession #) View looking northwest at the façade, April 24, 2006

Alterations to the building include the enclosure of the front porch. The condition of the building is good.

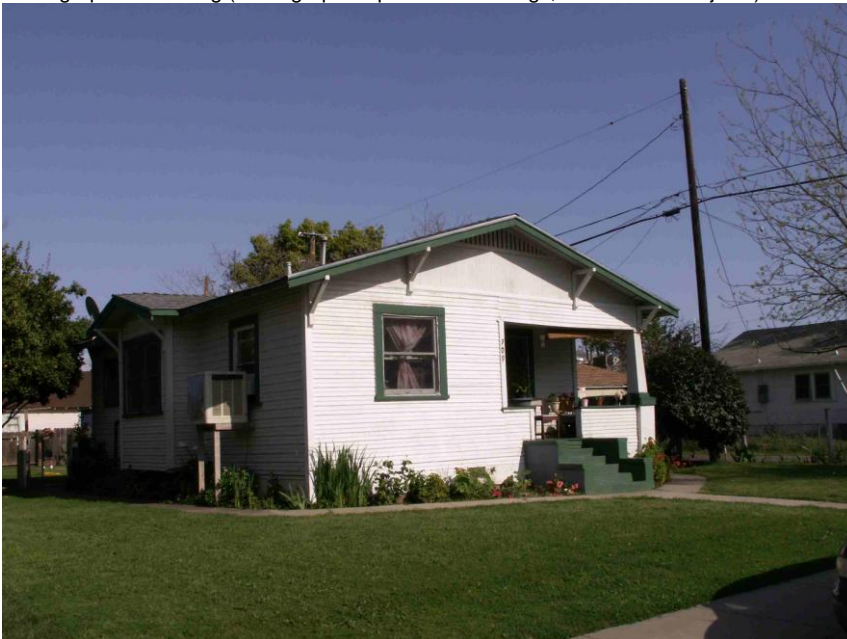
**P5b. Description of Photo:** (view, date, accession #) View looking southeast at the façade, April 24, 2006

Alterations to the building include the addition of a porch on the east elevation (rear) of the building. The condition of the building is good.

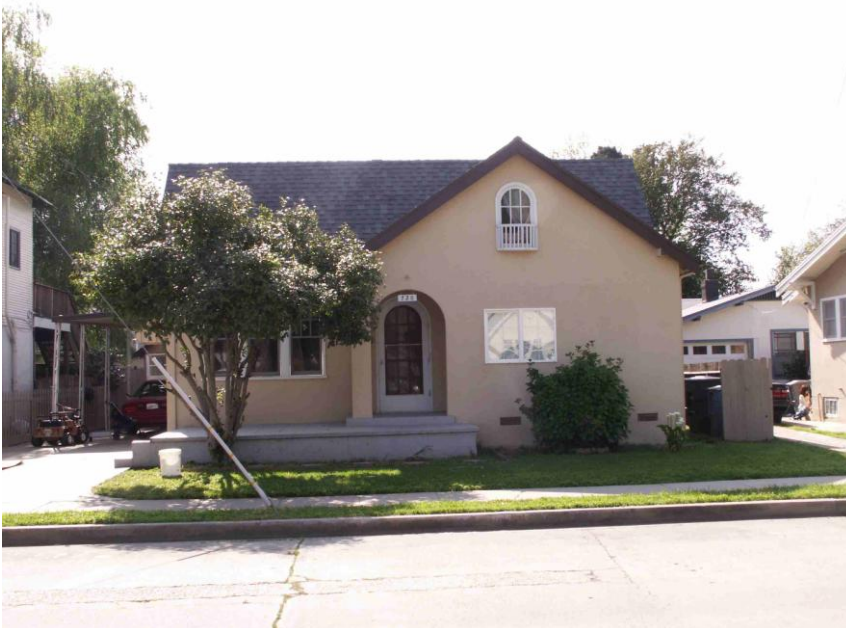
P5b. Description of Photo: (view, date, accession #) View looking west at the façade, April 24, 2006

Alterations to the building include some replacement windows. The condition of the building is good.

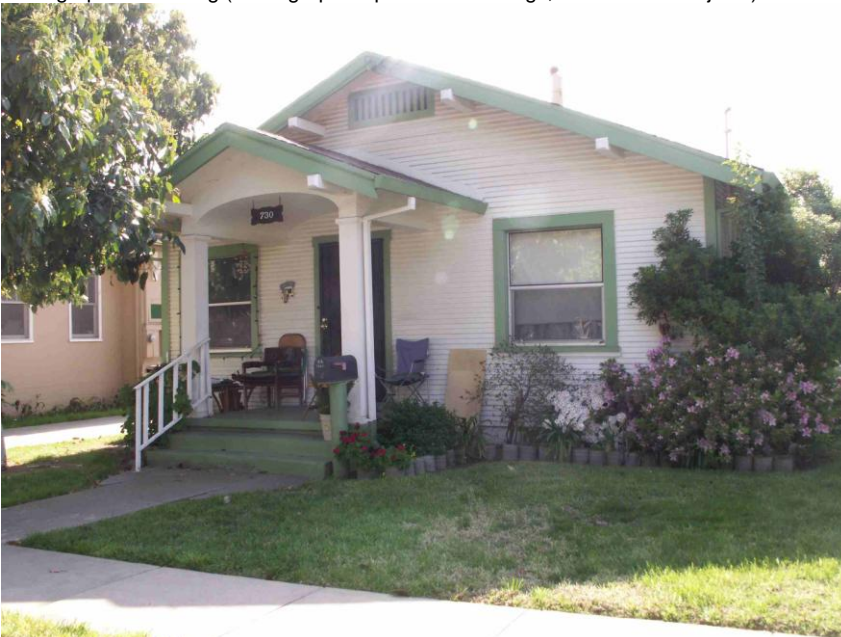
**P5b. Description of Photo:** (view, date, accession #) View looking southwest at the façade, April 24, 2006

Alterations to the building include replaced windows. The condition of the building is good.

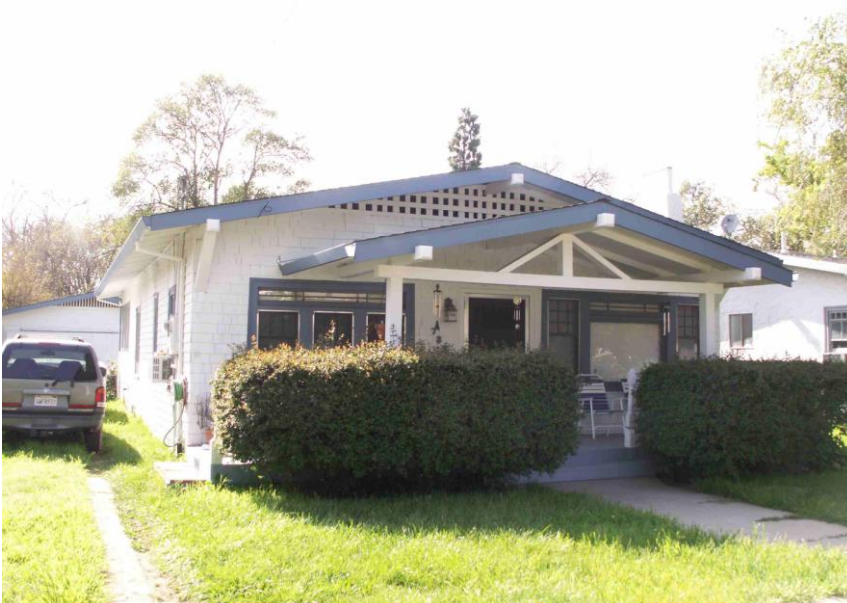
**P5b. Description of Photo:** (view, date, accession #) View looking northwest at the façade, April 24, 2006

Alterations to the building include the replaced porch steps and landing. The condition of the building is good.

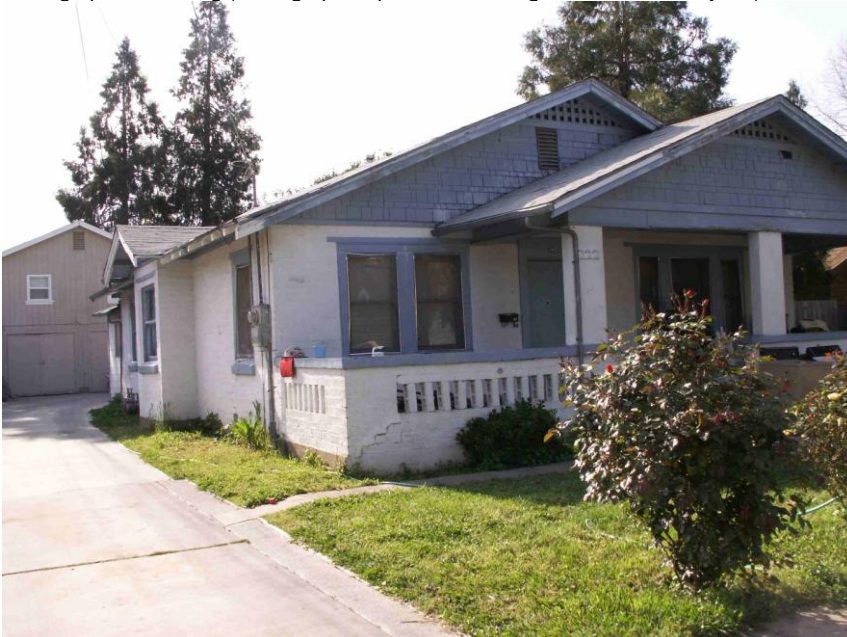
**P5b. Description of Photo:** (view, date, accession #) View looking northwest at the façade, April 24, 2006

Alterations to the building include the replacement of the original main entry door and a room addition to the west elevation of the residence. The condition of the building is good.

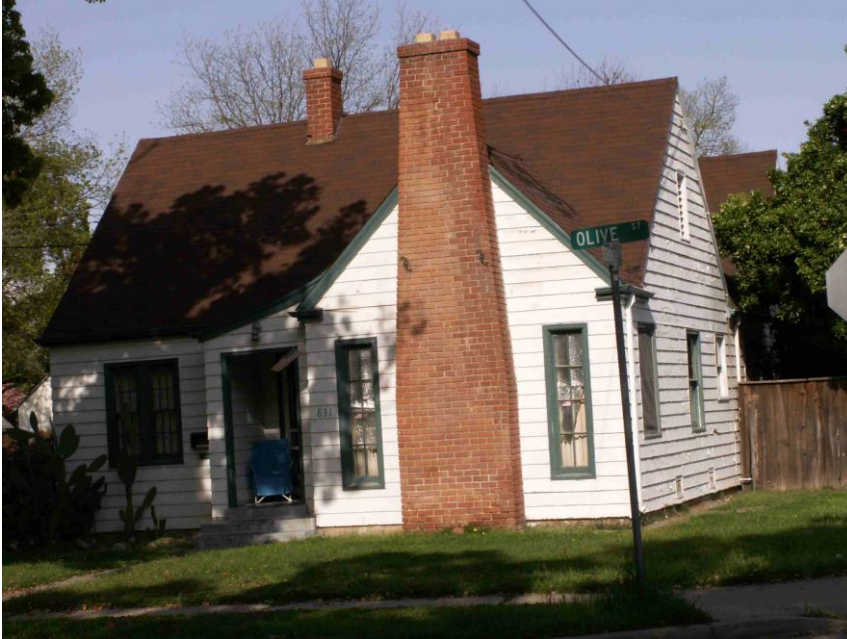
**P5b. Description of Photo:** (view, date, accession #) View looking northeast at the façade, April 24, 2006

Alterations to the building include an addition likely made to the east (rear) elevation. The condition of the building is good.

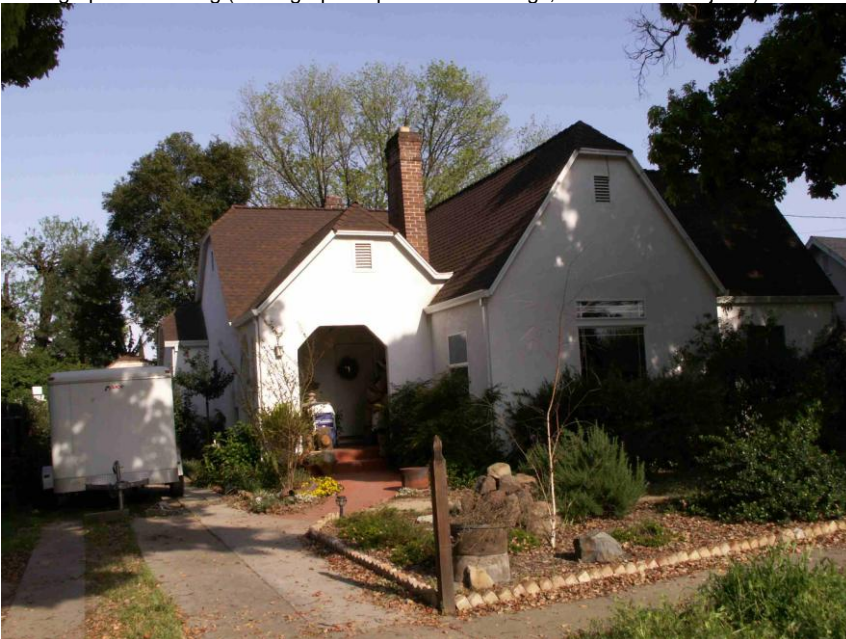
**P5b. Description of Photo:** (view, date, accession #) View looking southeast at the façade, April 24, 2006

Alterations to the building include the replacement of the original windows. The condition of the building is good.
