PRIMARY RECORD

*Resource Name or # (Assigned by recorder) 448 Park Avenue, Yuba City

*P11. Report Citation: (Cite survey report and other sources, or enter "none.") Sutter County Historic Survey (Galvin Preservation Associates, 2005-2007)

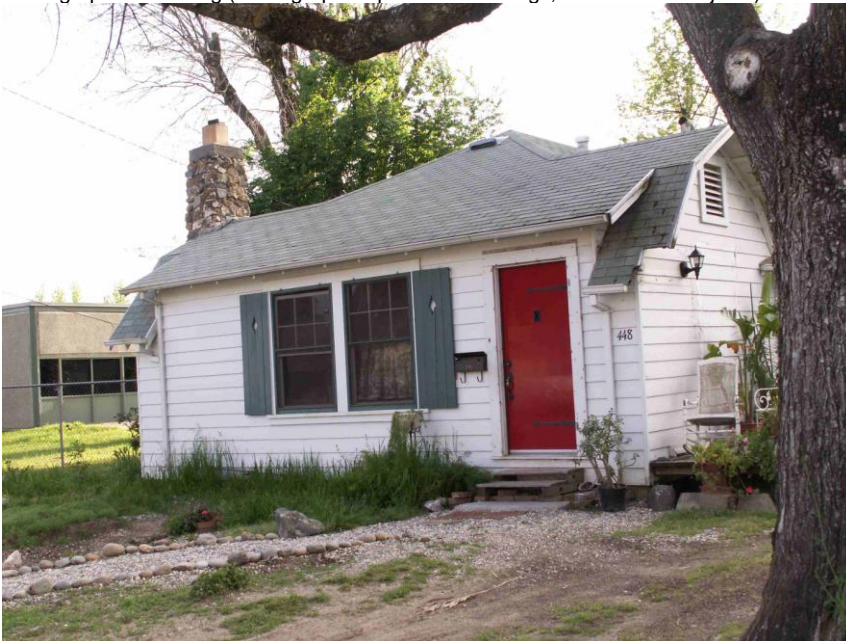
P5b. Description of Photo: (view, date, accession #) View looking southwest at the façade, April 24, 2006

Alterations to the building include possible modifications made to the façade. The condition of the building is good.

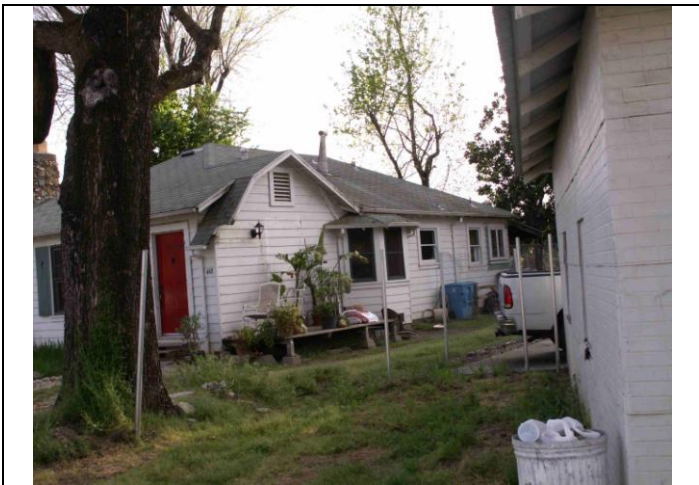
View looking southwest at the north elevation

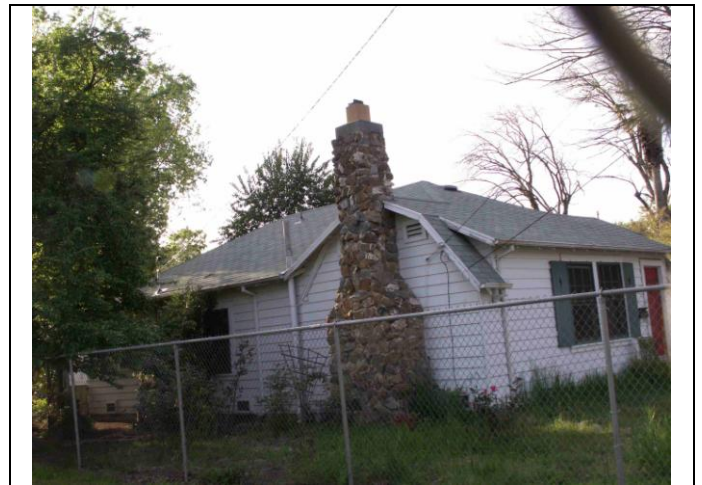
View looking northwest at the south elevation

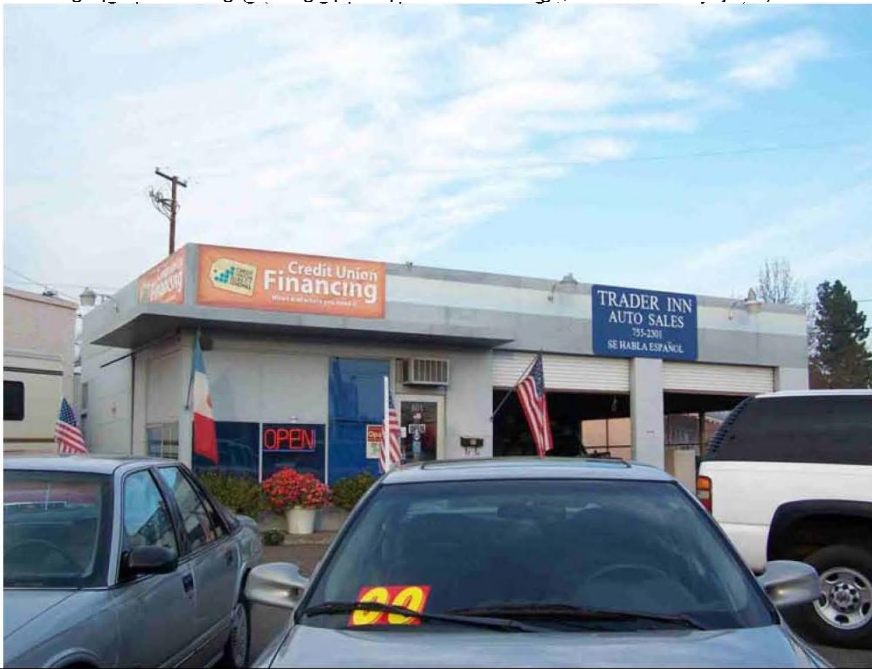
P5b. Description of Photo: (view, date, accession #) View looking northeast at the façade.
December 12, 2005
*P6. Date Constructed/Age and Sources: ☒ Historic ☐ Prehistoric ☐ Both
Circa 1946, 1946 Yuba City City Directory
*P7. Owner and Address: Manfred Chin
1355 Marlborough Rd.
Burlingame, CA 94010
*P8. Recorded by: Name, affiliation, and address) Christeen Taniguchi/Laura Gallegos/
Ben Taniguchi
Galvin Preservation Associates Inc.
1611 S. Pacific Coast Hwy. Suite 104
Redondo Beach CA, 90277
*P9. Date Recorded: January 6, 2006
*P10. Survey Type: (Describe) ☐ Intensive ☒ Reconnaissance

Alterations include blacking out the top window panels and the installation of an air conditioning unit above the main entrance. The condition of the building is good to fair.

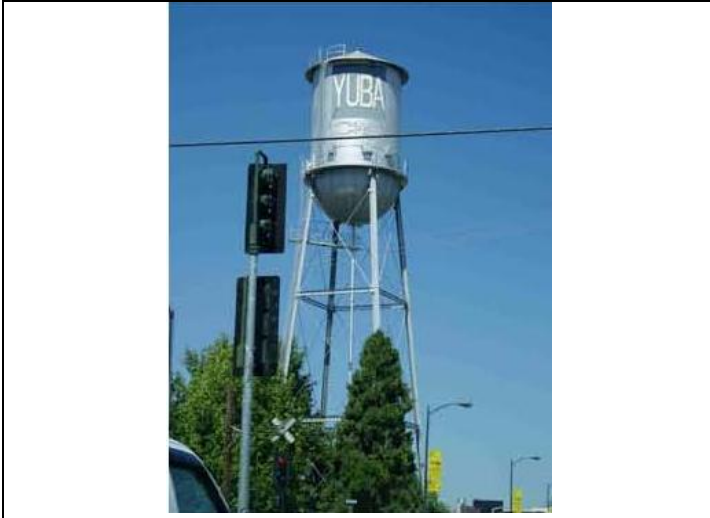
Figure 3. View looking northwest at the water tank

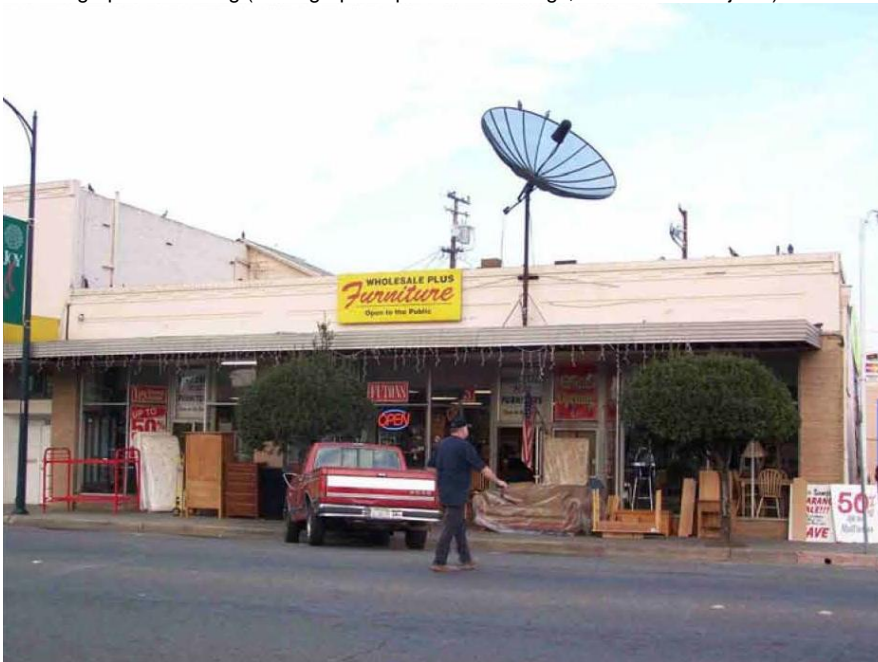
P5b. Description of Photo: (view, date, accession #) View looking northeast at the facade
December 12, 2005

Alterations include the remodeling of the storefront in circa 1950s and the addition of a large satellite dish on top of the façade overhang. The condition of the building is good to fair.

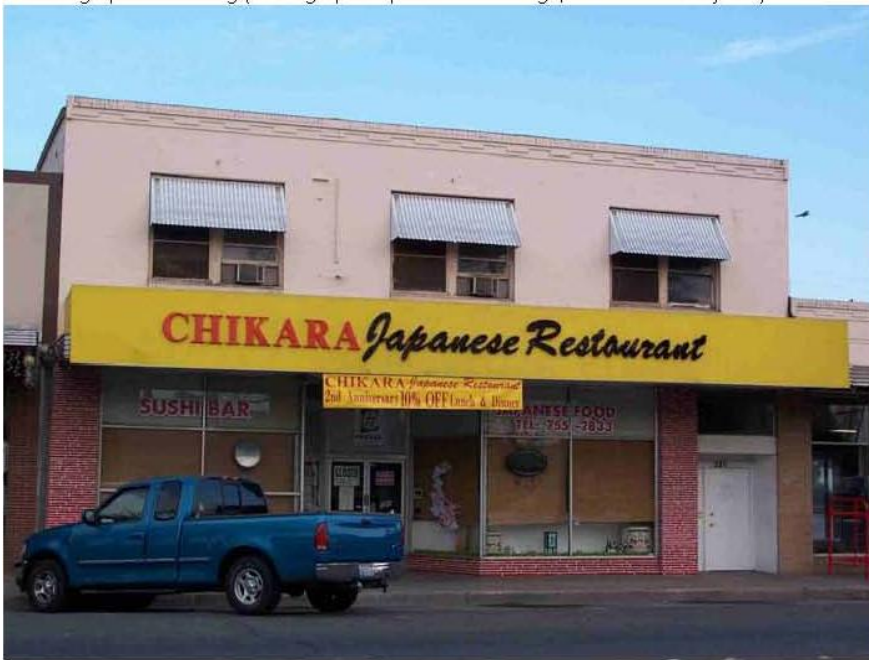
P5b. Description of Photo: (view, date, accession #) View looking southeast at the facade
December 12, 2005
*P6. Date Constructed/Age and Sources: ☒ Historic ☐ Prehistoric ☐ Both
Circa 1927, 1927 Yuba City Sanborn map
*P7. Owner and Address: Shao Ying Han
133 Sadowa Street
San Francisco, CA 94112
*P8. Recorded by: Name, affiliation, and address) Christeen Taniguchi/Laura Gallegos/
Ben Taniguchi
Galvin Preservation Associates Inc.
1611 S. Pacific Coast Hwy. Suite 104
Redondo Beach CA, 90277
*P9. Date Recorded: January 6, 2006
*P10. Survey Type: (Describe)
☐ Intensive
☒ Reconnaissance

The building fronts onto Plumas Street and is set behind the sidewalk. There are no ancillary buildings on this property. Alterations include the remodeling of the first floor in the circa 1950s and the addition of a large marquee over the cantilevered overhang and aluminum awnings over the second floor windows, as well as air conditioning units present in the windows. The condition of the building is fair.

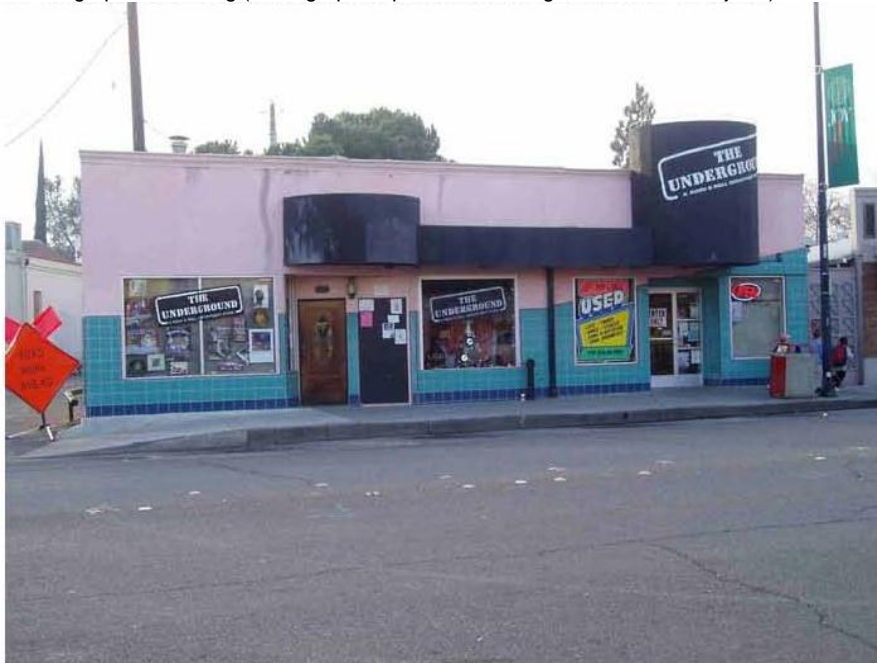
The building fronts onto Plumas Street and is set behind the sidewalk. There are no visible ancillary buildings on this property. Alterations include the remodeling of the storefront in the circa 1980s and the addition of half-cylinder awnings over the doors, and the cladding of the lower half of the facade in light and dark blue ceramic tiles. The condition of the building is good.

P5b. Description of Photo: (view, date, accession #) View looking northwest at the facade
December 12, 2005

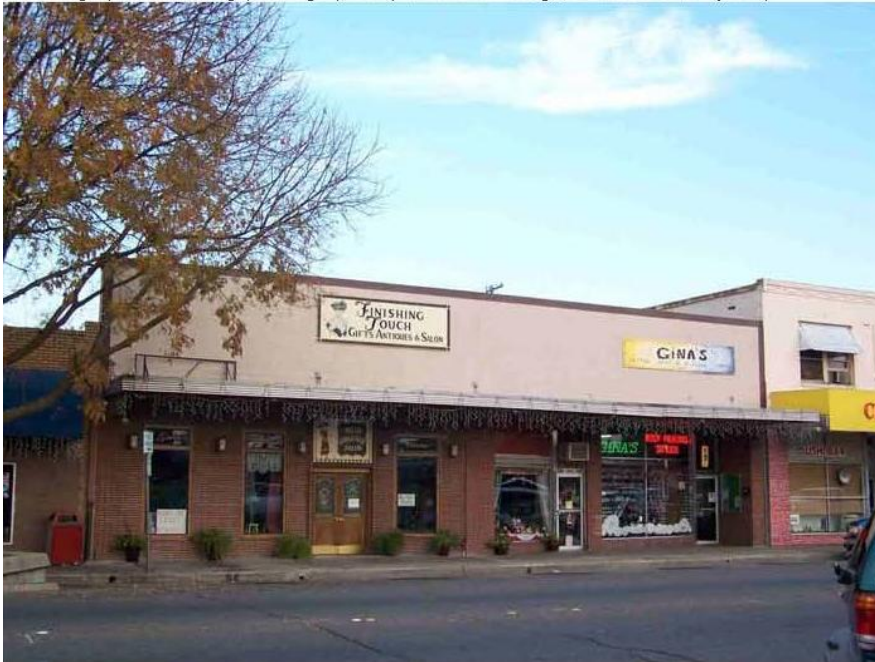
The building fronts onto Plumas Street and is set behind the sidewalk level. Landscaping elements include a few potted plants at the building's façade. There are no ancillary buildings on this property. Alterations include the remodeling of the store front in the circa 1960s. The condition of the building is good.

P5b. Description of Photo: (view, date, accession #) View looking southeast at the facade
