PRIMARY RECORD

*Resource Name or # (Assigned by recorder) 2073 Railroad Avenue, Yuba City

***P11. Report Citation:** (Cite survey report and other sources, or enter "none.") Sutter County Historic Survey (Galvin Preservation Associates, 2005-2007)

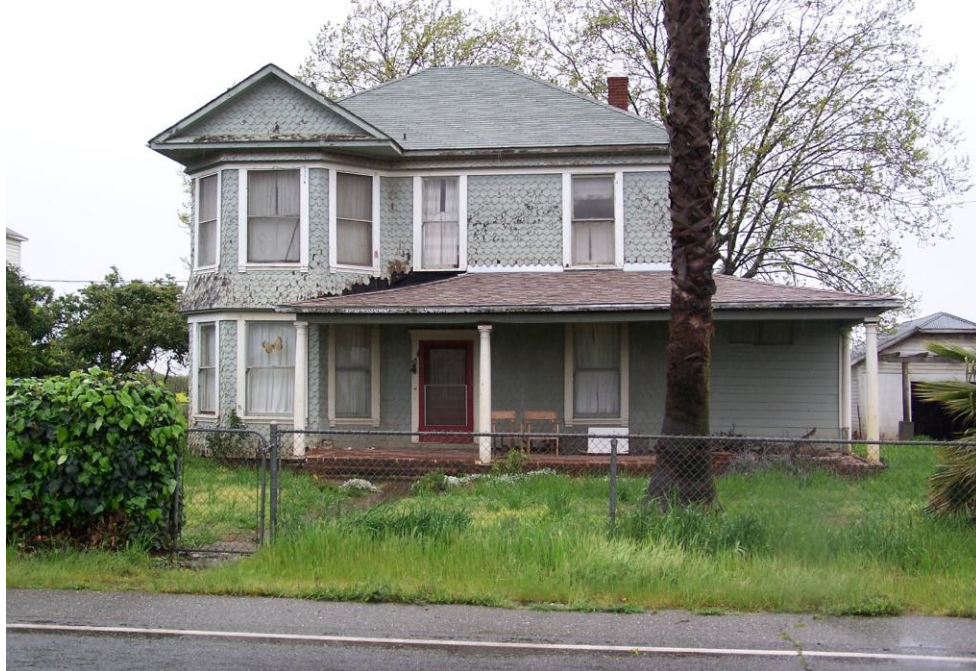
P5b. Description of Photo: (view, date, accession #) View looking west at the façade, July 18, 2006

Alterations to the building include an addition on the north and west elevations. The condition of the main residence is fair and the tankhouse is in poor condition.

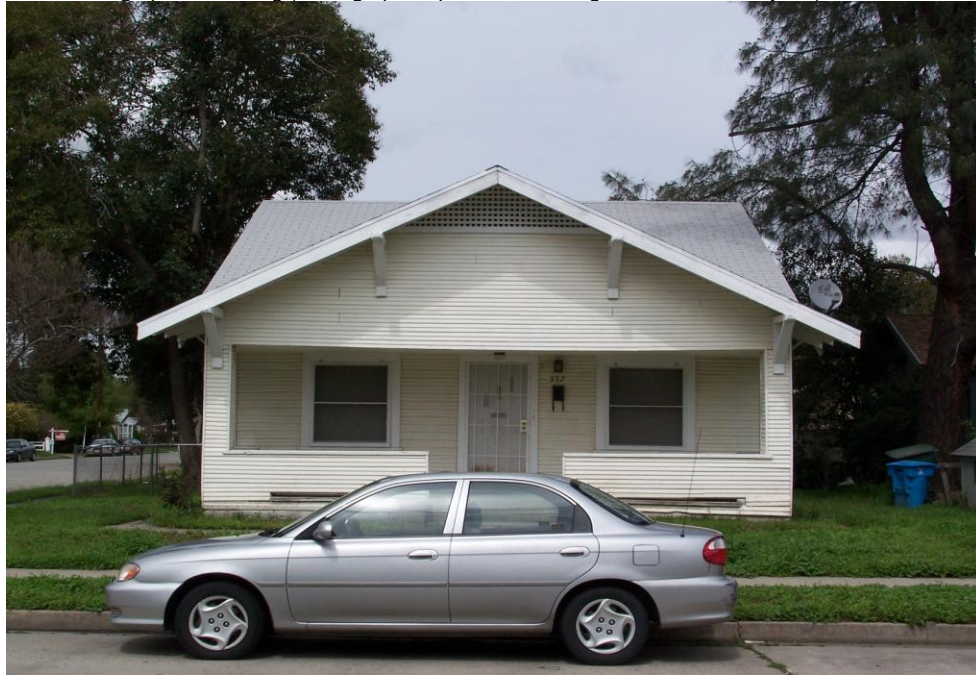
P5b. Description of Photo: (view, date, accession #) View looking north at the façade, July 18, 2006

Alterations to the building include the replacement of the façade door. The condition of the building is good.

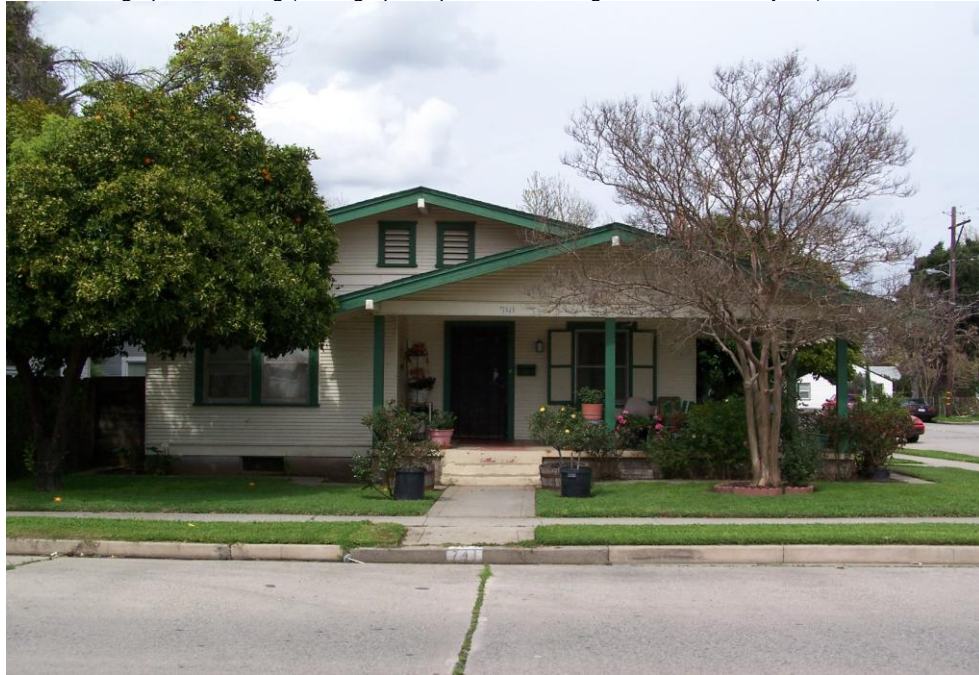
P5b. Description of Photo: (view, date, accession #) View looking north at the façade, July 18, 2006

Alterations to the building include the addition of shutters at façade windows. The condition of the building is good.

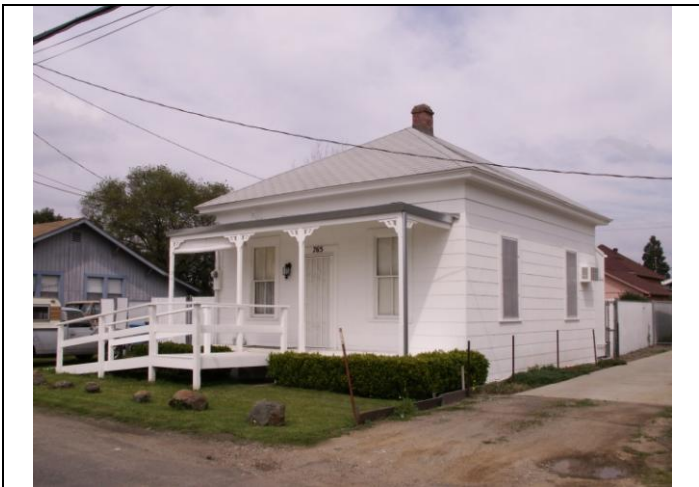
Alterations to the building include the wheelchair ramp at the front porch and the front-gabled single-car garage. The condition of the building is good.

View looking northeast at the façade and south elevations

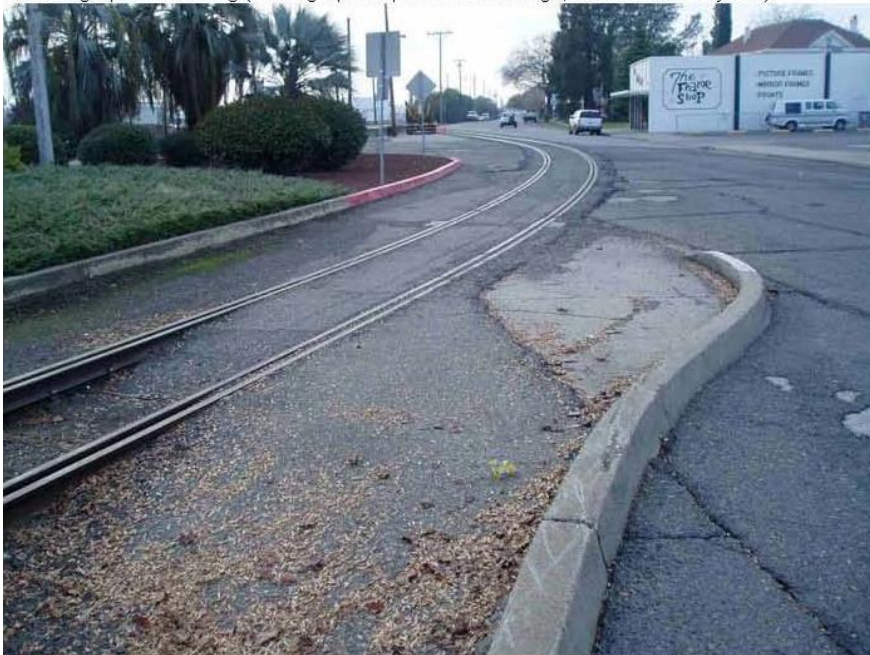
The standard gauge (distance between the rails) is 4' 8.5". The tracks are made with welded steel 5" x 7" rails that are laid on wood ties. The standard length of the rails is 39'. The average tie height is 7" and the average tie width is 9", although these are covered in asphalt so could not be observed. The length of the ties within the rail segment generally varies between eight to nine feet long. The wood ties of the evaluated line are most likely held down by tie plates and spikes. It is likely that the rails, ties and plates rest on a bed of ballast, likely of granite. The exposed rails are in good to excellent condition.

P5b. Description of Photo: (view, date, accession #) View looking

West at the rail lines along Reeves Ave (the Sacramento Northern Railway Depot was located to the south); December 12, 2005

The overall integrity of the rail lines is fair. Their condition is good to excellent.

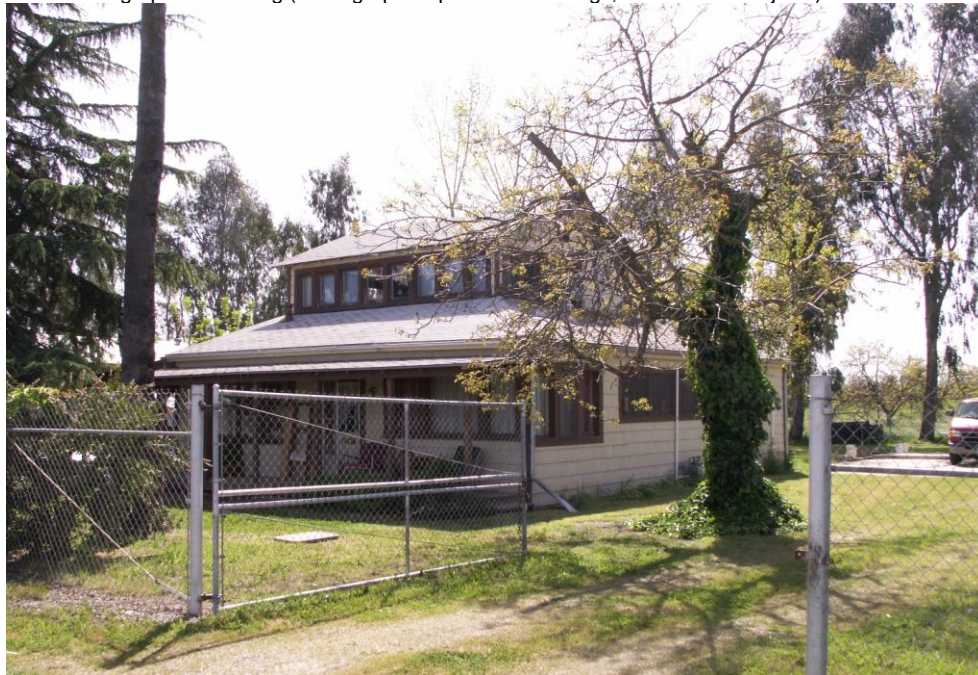
P5b. Description of Photo: (view, date, accession #) View looking west at the façade, March 23, 2006

Alterations to the property include the enclosure of the original porch and the addition of a narrow porch at the façade as well as the addition of a porch on the south elevation. The condition of the building is good to fair.

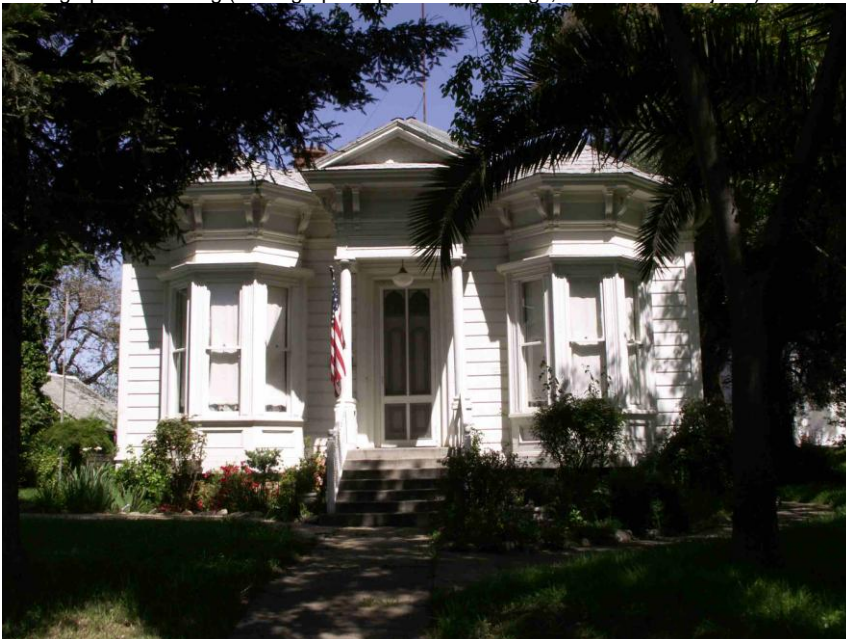
P5b. Description of Photo: (view, date, accession #) View looking east at the façade, April 19, 2006

Alterations to the building include an addition to the east elevation of the residence. The condition of the building is good.

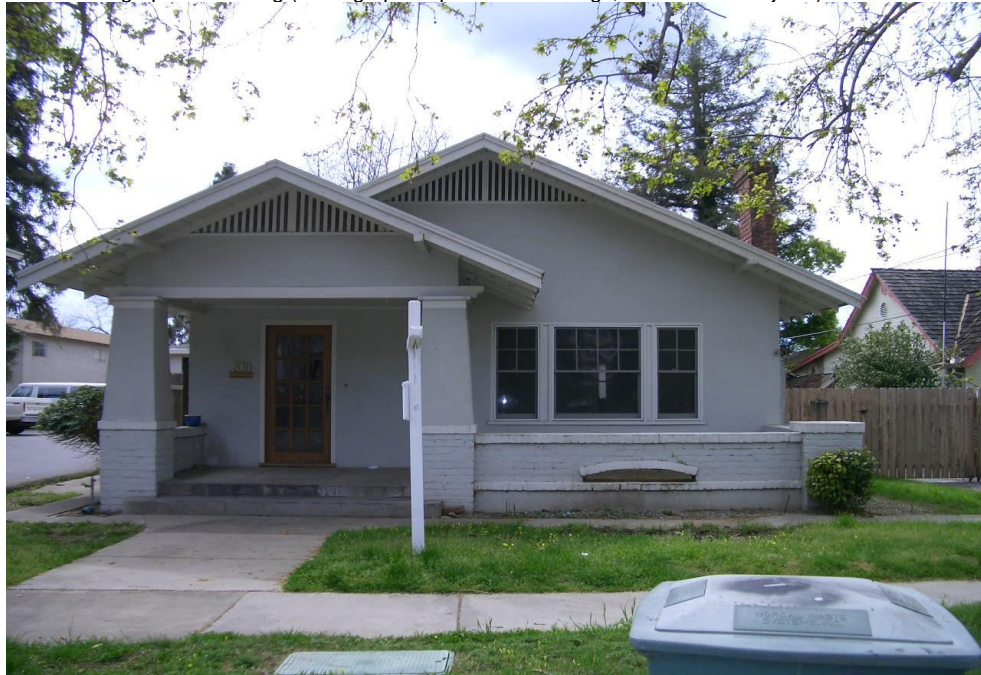
P5b. Description of Photo: (view, date, accession #) View looking west at the façade, July 18, 2006

Alterations to the building include the re-surfacing of the exterior in smooth stucco, the replacement of the south elevation windows and the replacement of the front door. The condition of the building is good.

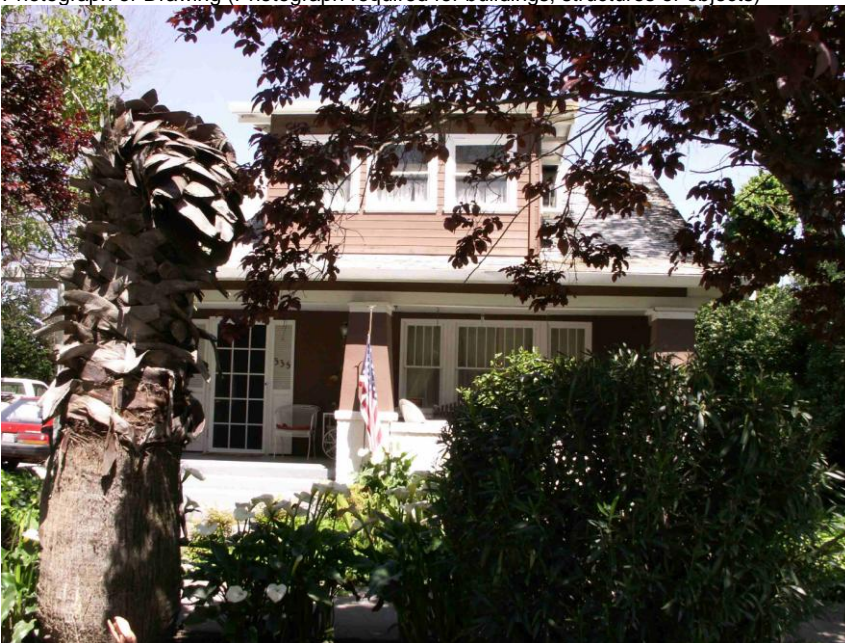
P5b. Description of Photo: (view, date, accession #) View looking east at the façade, April 19, 2006

Alterations to the building include the addition of a half story. The condition of the building is good.

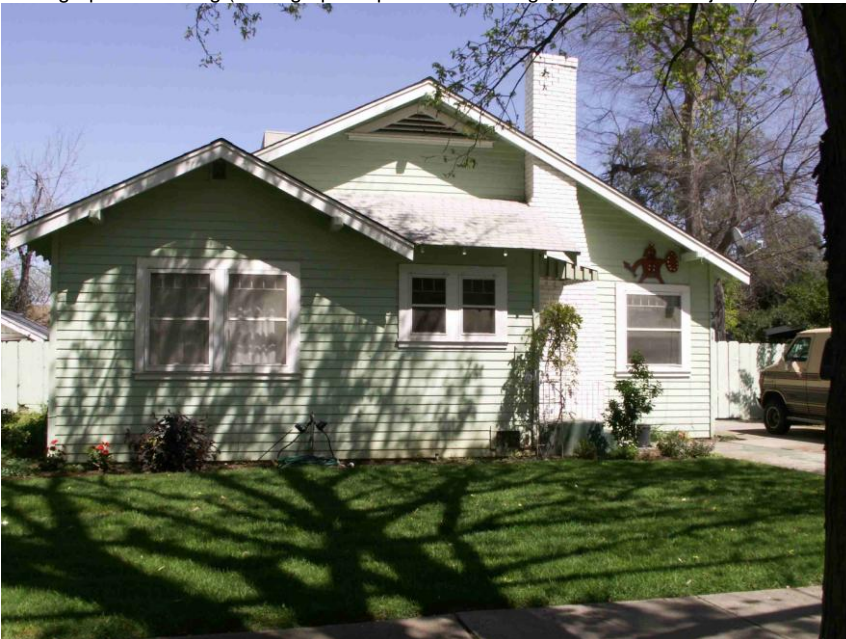
P5b. Description of Photo: (view, date, accession #) View looking east at the façade, April 19, 2006

Alterations to the building include the possible early addition of a second story as well as the installation of a metal awning over the main entry door. The condition of the building is good.

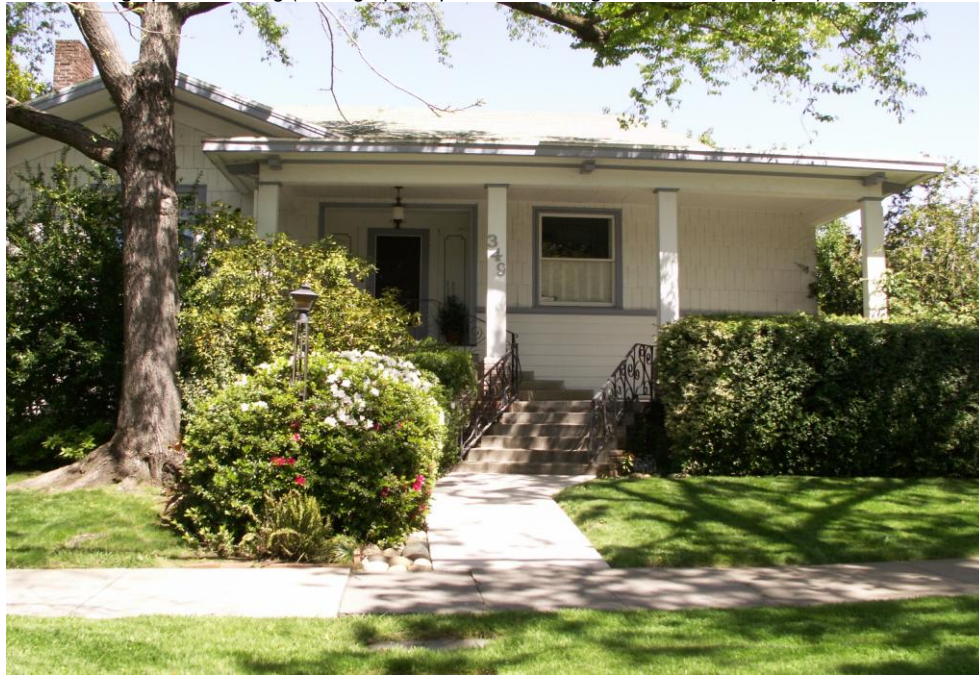
P5b. Description of Photo: (view, date, accession #) View looking east at the façade, July 18, 2006

Alterations to the building include the addition of a room and deck on the east elevation as well as the replacement of the original windows on the east elevation. The condition of the building is good.

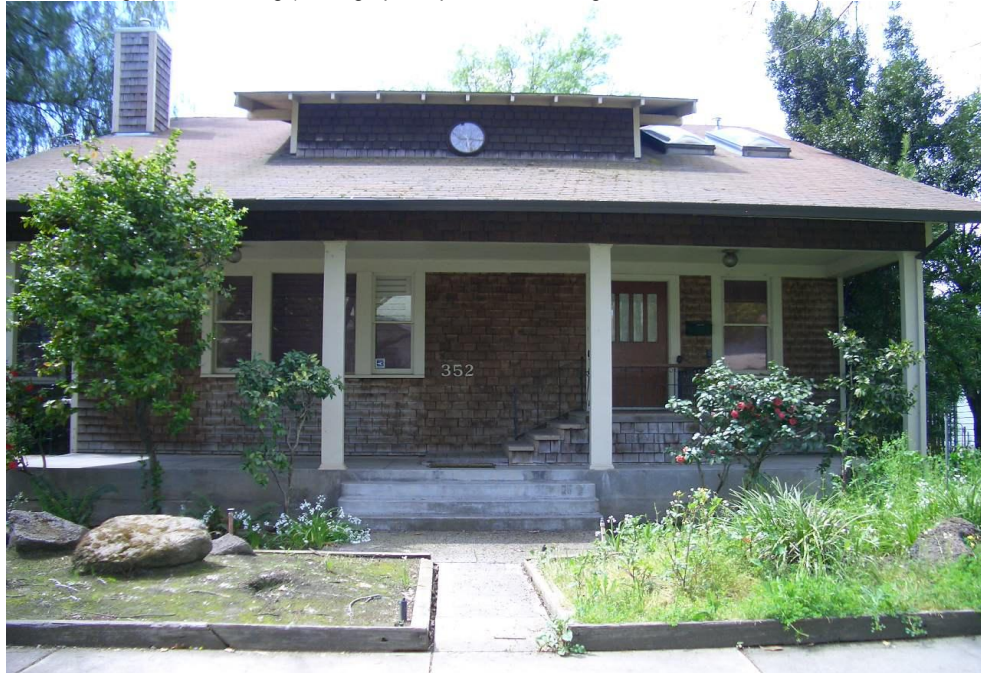
P5b. Description of Photo: (view, date, accession #) View looking west at the façade, July 18, 2006

Alterations to the building include the re-siding of the exterior, the replacement of the front porch and an early addition to the south elevation. The condition of the building is good.

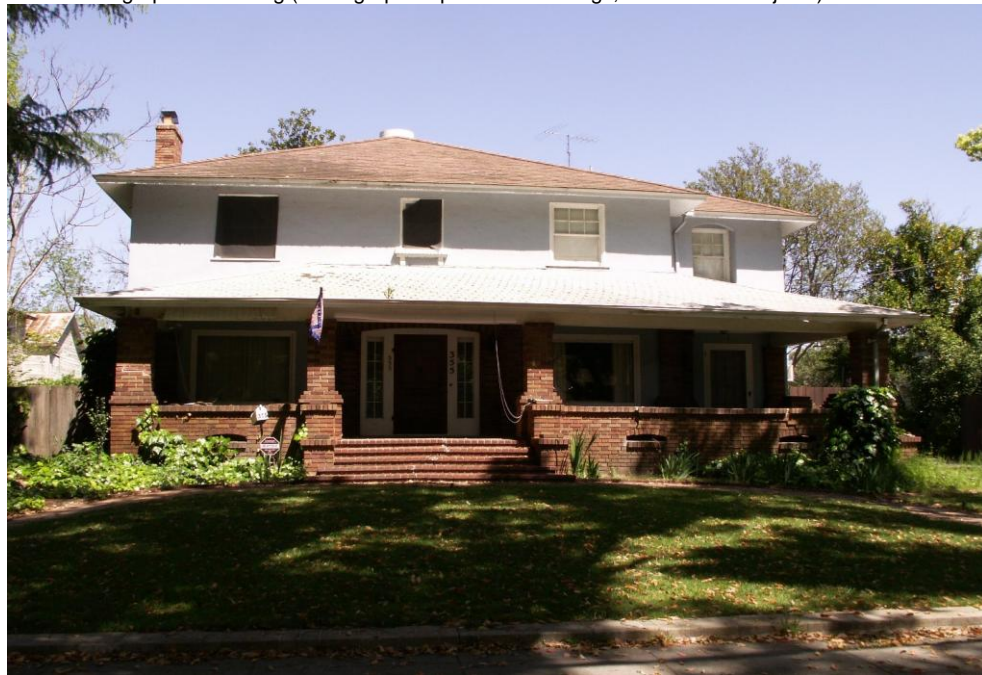
P5b. Description of Photo: (view, date, accession #) View looking east at the façade, July 18, 2006

Alterations to the building include the picture windows at the façade, and the brick leading to the front porch appears newer than the rest of the residence. The condition of the building is excellent to good.

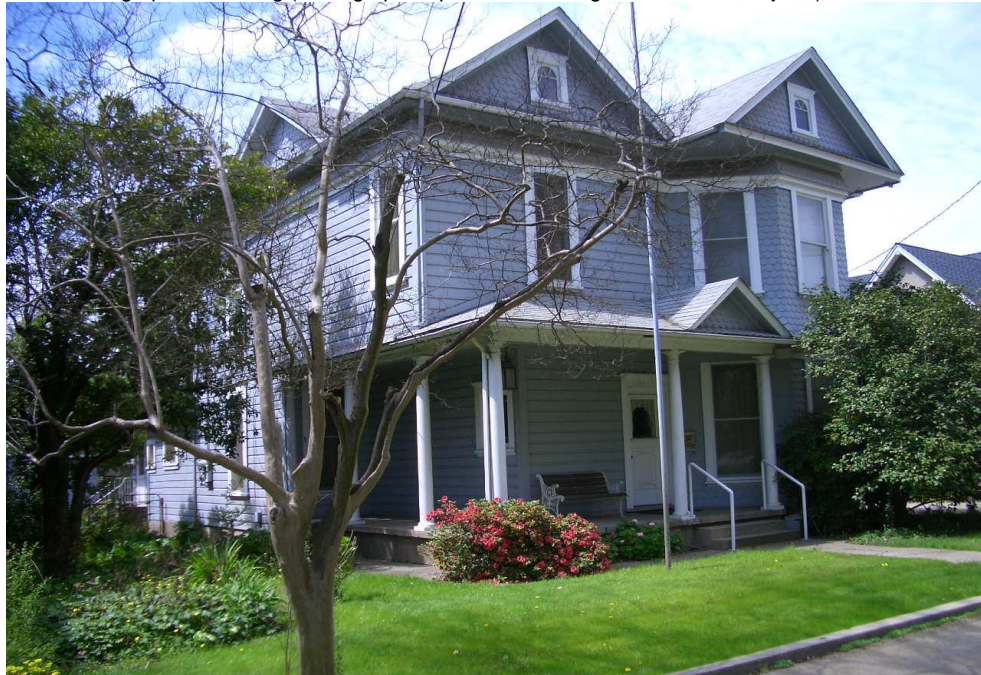
P5b. Description of Photo: (view, date, accession #) View looking northwest at the façade and south elevation, July 18, 2006

Alterations to the building include an early one-story addition to the west elevation. The condition of the building is excellent to good.

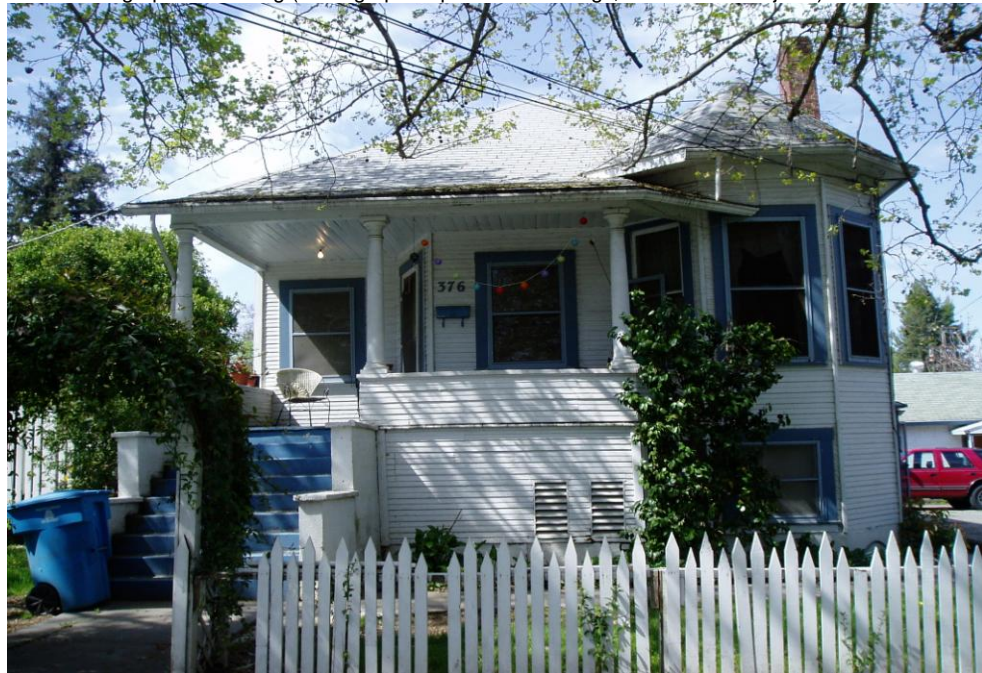
P5b. Description of Photo: (view, date, accession #) View looking west at the façade, July 18, 2006

Alterations to the residence include the enclosure of the entrance on the north elevation. The condition of the building is good to fair.
