PRIMARY RECORD

*Resource Name or # (Assigned by recorder) 2073 Railroad Avenue, Yuba City

***P11. Report Citation:** (Cite survey report and other sources, or enter "none.") Sutter County Historic Survey (Galvin Preservation Associates, 2005-2007)

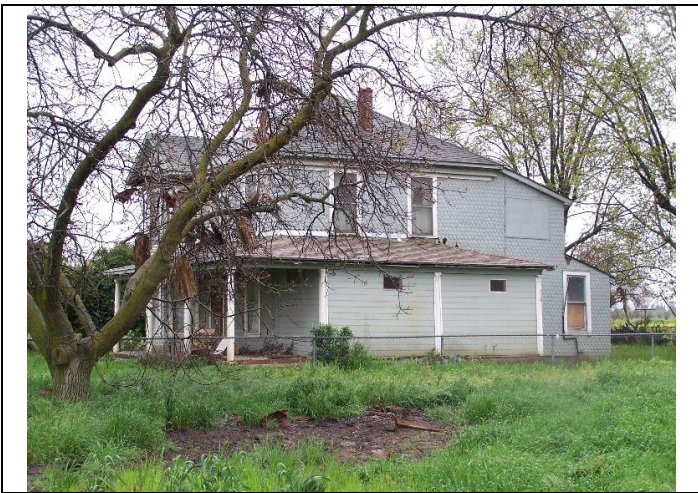
View looking south at the north elevation

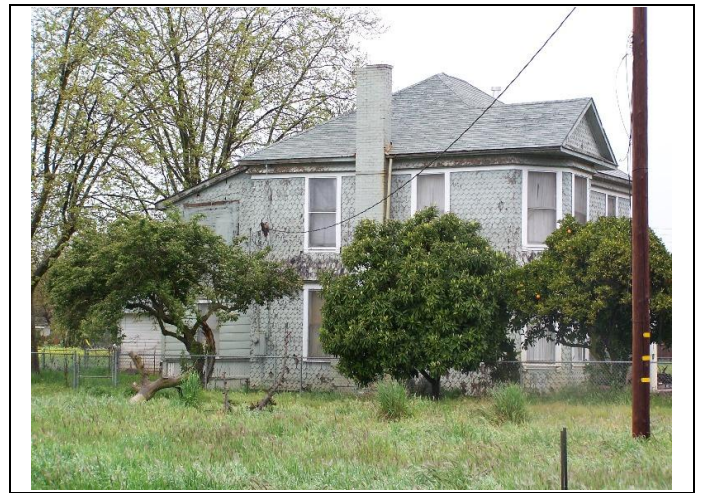
View looking north at the south elevation

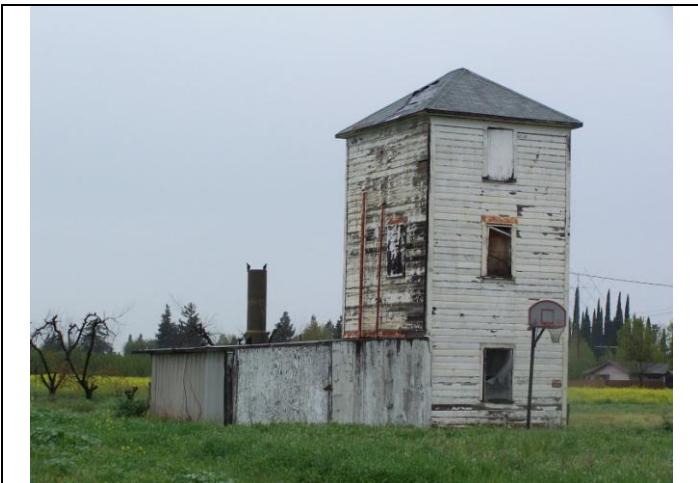
Alterations to the building include an addition on the north and west elevations. The condition of the main residence is fair and the tankhouse is in poor condition.

View looking at the tankhouse located south of the primary residence

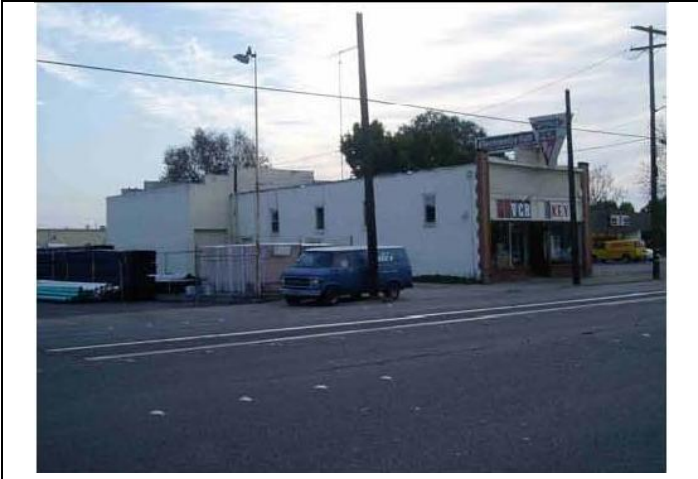
View looking south at the rail lines down the center of Bridge Street between Plumas and Shasta Streets

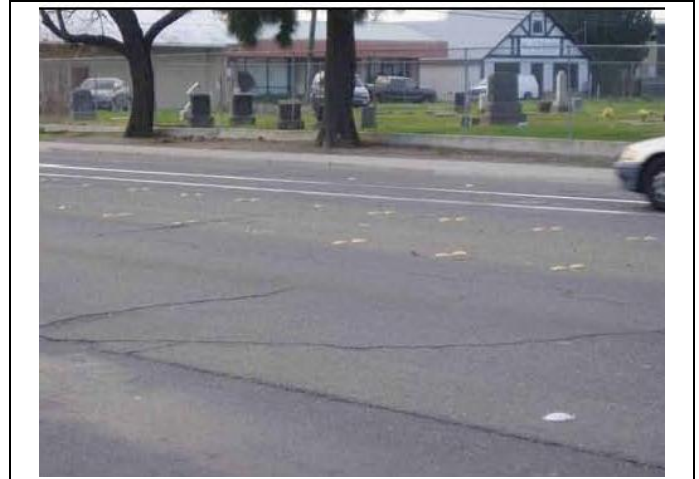
View looking west at the rail line down the center of Bridge Street, with the Yuba City Cemetery in the background

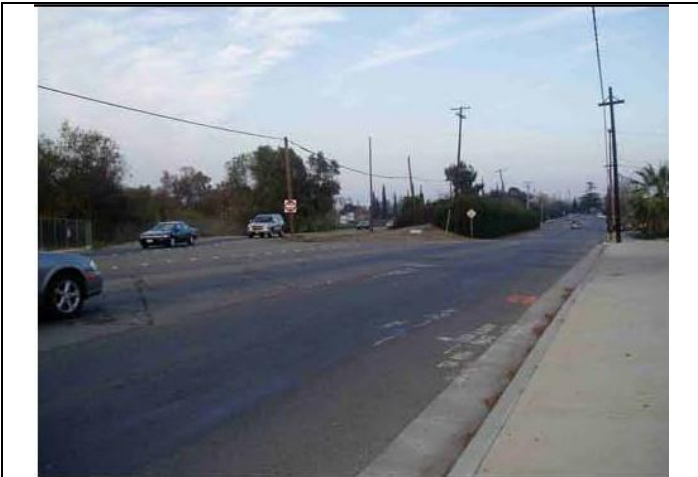
View looking north at the rail line as it curves to the northwest side of Bridge Street onto the top of a hill. In the west background is a road that connects to the Twin Cities Memorial Bridge.
